Soil solutions: improving water management across Sydney's public open spaces

Alisa Bryce and Andrew Porter

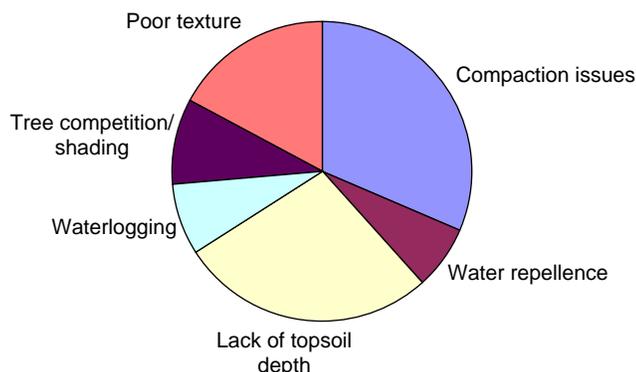
Figure 1 presents the six (6) main issues identified throughout the assessments. Compaction and lack of topsoil depth are most common, with 64% of sites experiencing compaction, and 56% having inadequate topsoil depth. Approximately 35% of the sites had a poor topsoil texture, 19% were subjected to tree competition/shading and water logging was observed at 16% of the sites, indicating poor drainage. Water repellence was observed at 14% of the sites.

Figure 1 | Common issues observed across Sydney's public open space.

Of these six issues, five can be attributed to or are dependent upon soil characteristics.

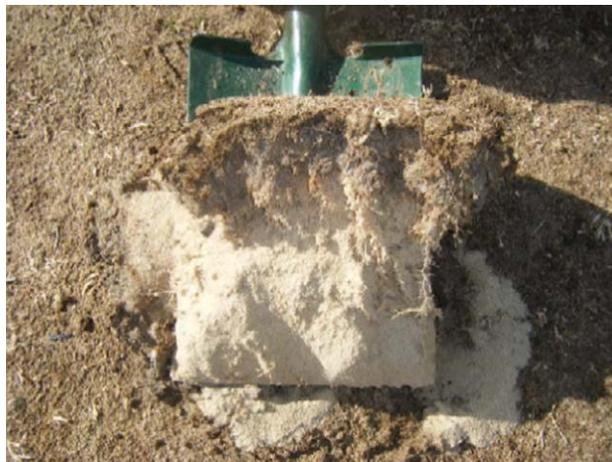
Figure 2 | A typical sand profile. Note the bare patches on the surface.

Ascertaining the correct soil texture is, like most public open space management issues, highly dependent upon the historical construction methods of the site and the degree of foot traffic the site is subjected to. A very sandy profile (Figure 2) will not have the capacity to hold the water and nutrients required for turf growth without regular supplementary irrigation, whilst a heavy textured soil (clay profile) will readily compact.

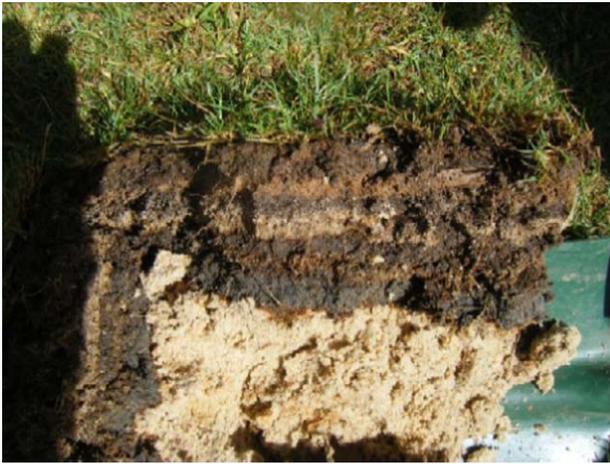
Figure 3 | Profile layering. Note the clay layers above a sandy profile.

'Layering' within a soil profile has the potential to reduce the size of the 'soil water tank' by impeding water filtration into the profile, and therefore the turf root zone. Management regimes involving topdressing with materials of differing texture is often the main culprit behind soil layering (Figure 3), particularly when imported turf is grown in a clay loam underlay.

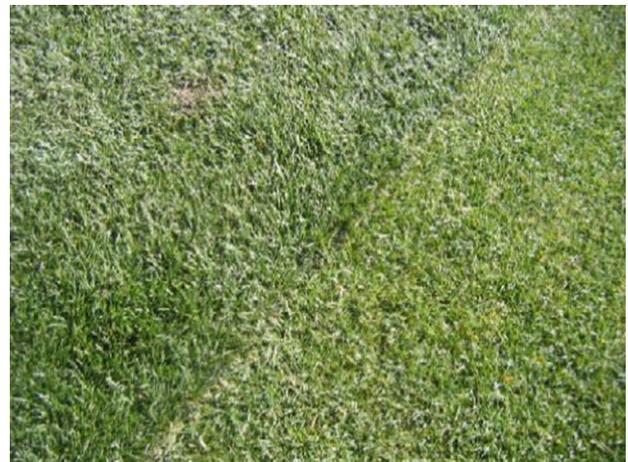
Figure 4 | Elite sports turf.

Water is a necessity for all plant growth, however the amount required in public open space depends on (and is driven by) the dual standards of acceptance/expectations and use. First class coverage is expected of an elite sports field, whilst a lesser standard is accepted on a local field. With respect to use, elite sports fields are constantly in use, and often have the resources and budgets to sufficiently manage the wear and tear this causes. Interestingly, recent social trends have placed more pressure on outdoor activities, leading to an increase in the number of sporting clubs and matches. It is not uncommon for a local sports field to be in use every afternoon and evening for training (under lights), all weekend for matches and during week days by school groups. Typically these local fields do not have the budgets or resources for maintenance and repair that the elite surfaces have. Accordingly, **Figures 4** and **5** show the clear contrast in turf quality between an elite and local sports turf.

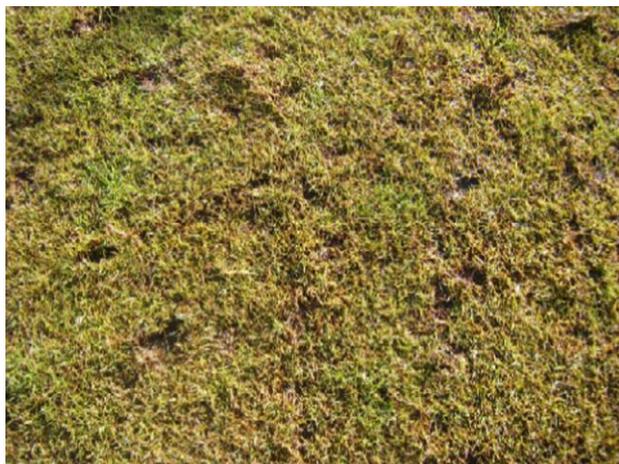
Figure 5 | Local sports turf.

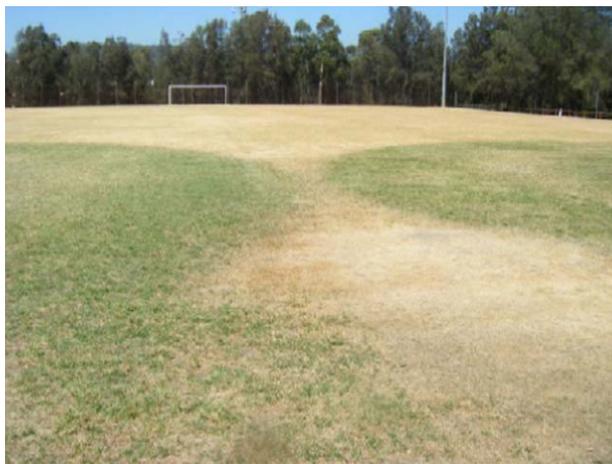
Lack of head to head coverage is another common issue leading to inefficient water application and a stark difference in turf growth and quality. As evident in [Figure 6](#), turf exposed to good water coverage is healthy and growing (green) whilst other turfed areas have gone into dormancy (white), on the same field. The pattern of irrigation is therefore easy to see.

Figure 6 | Inefficient water application.

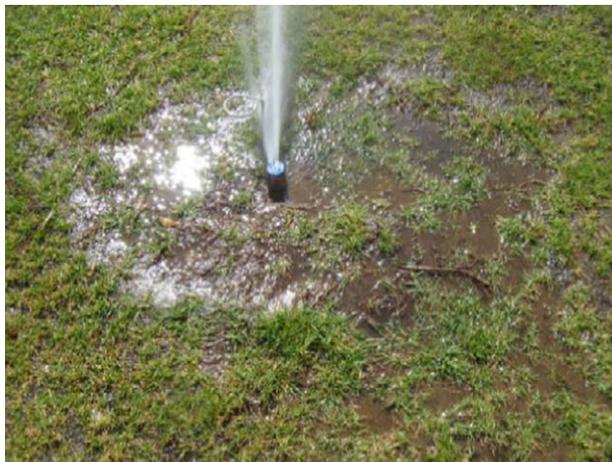
Although a lack of maintenance will result in the gradual decline of a system, foot traffic on a field often results in broken/bent heads, whilst crucial maintenance regimes such as topdressing gradually bury the system, requiring it to be lifted every few years ([Figure 7](#)). Sunken sprinkler heads were a common feature of Sydney's sports fields.

Figure 7 | Sunken sprinkler head.

Simple methods such as ensuring the same sprinkler head is used across the site, maintaining system pressure at 400 kPa and replacing broken sprinkler heads will aid in increasing the efficiency of an irrigation system.
