Chapter 4

Rainwater catchment on Hawai'i Island

Patricia S. Macomber

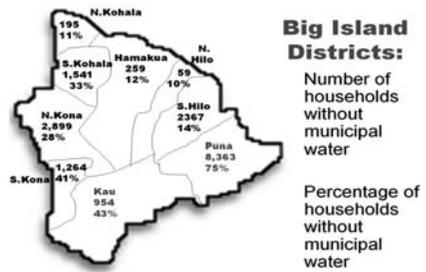
Figure 4.2 Municipal water availability. (Source: HFD, 2008).

The current population of the state of Hawaii is approximately 1.4 million. The majority of the population lives on the island of Oahu. The Big Island has a population of 200,983 (U.S. Census Bureau, 2018). It is larger than all the other major islands put together, with 63% of the land mass but only has 14% of the state's population. Much of the island is considered rural and those rural areas are generally lacking public utilities including water. Most of the homes without municipal water are on the south side of the island (Figure 4.2).

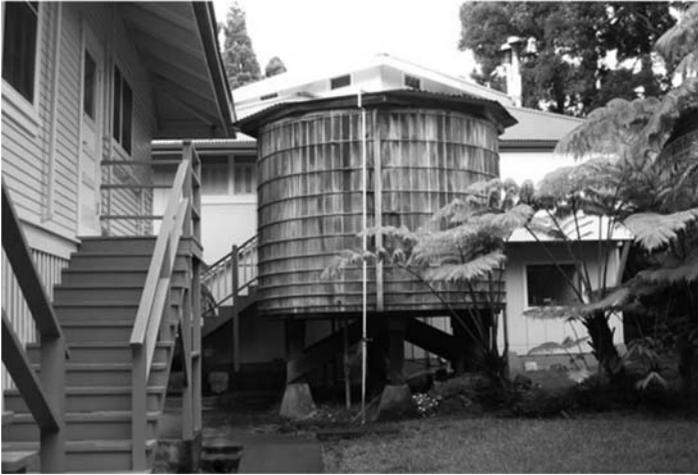
Figure 4.4 Old redwood tank located in the town of Volcano. (Source: Author).

Regular European contact with the islands started in the late 1700's and it was likely that water catchment became popular in the early 1800's. The older water tanks were usually wooden. A few old redwood tanks are still in use (Figure 4.4).

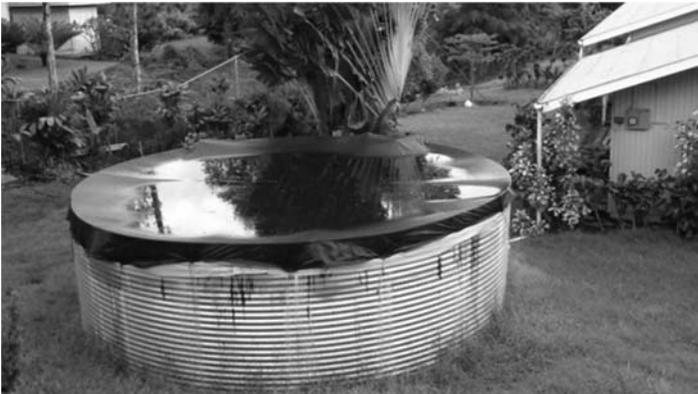
Figure 4.8 Permeable ground cover cloth commonly used as tank cover. (Source: Authors).

In 1981, a young woman bought her first home, a rural single-family home in southern Hawaii. The home's water tank was a portable, above-ground swimming pool with a soft permeable cover drooping into the water (Figure 4.8). The dragon flies were enjoying their artificial pond in the sagging center and the algae enjoyed a lovely bloom both outside and inside the tank.

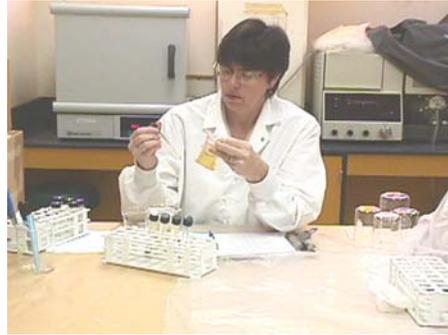
Figure 4.10 RCP water tests.

Initially testing was done at the University's Cooperative Extension office (Figure 4.10; Source: Authors), but as soon as a home test kit could be provided rural residents could easily pick up tests kits when they were in town and have them available when needed. This enabled the catchment owner to finally be able to manage their own systems, and know if what they were doing was successful. It also freed up the single RCP personnel to continue with other catchment

The Manja method was chosen because it used hydrogen-sulfide producing gut bacteria as indicators rather than the typical tests for *E. coli*. There are indigenous, non-gut *E. coli* found in the Islands which could lead to false positive results if using typical *E. coli* indicators (Hardina and Fujioka, 1991). Also, the Manja formula was less sensitive to temperature variations and could be used without incubation in lower elevations where temperatures were warm. This meant that a catchment user could do this test themselves at home (Rijal and Fujioka, 1995). One other note in favor of the Manja method testing is that the test results, if positive, encourages action by the homeowner due to its foul odor and color change from clear yellow to opaque black. This putrid ugly result has been known to convince even the adamant denier into cleaning his system. Once the program became established, the community need for it was easily confirmed and funding to expand services was easier to obtain.
