Implants With Internal Hexagon and Conical Implant-Abutment Connections: An In Vitro Study of the Bacterial Contamination

Key Words: bacterial contamination, dental implants, implant-abutment connections, microbial leakage

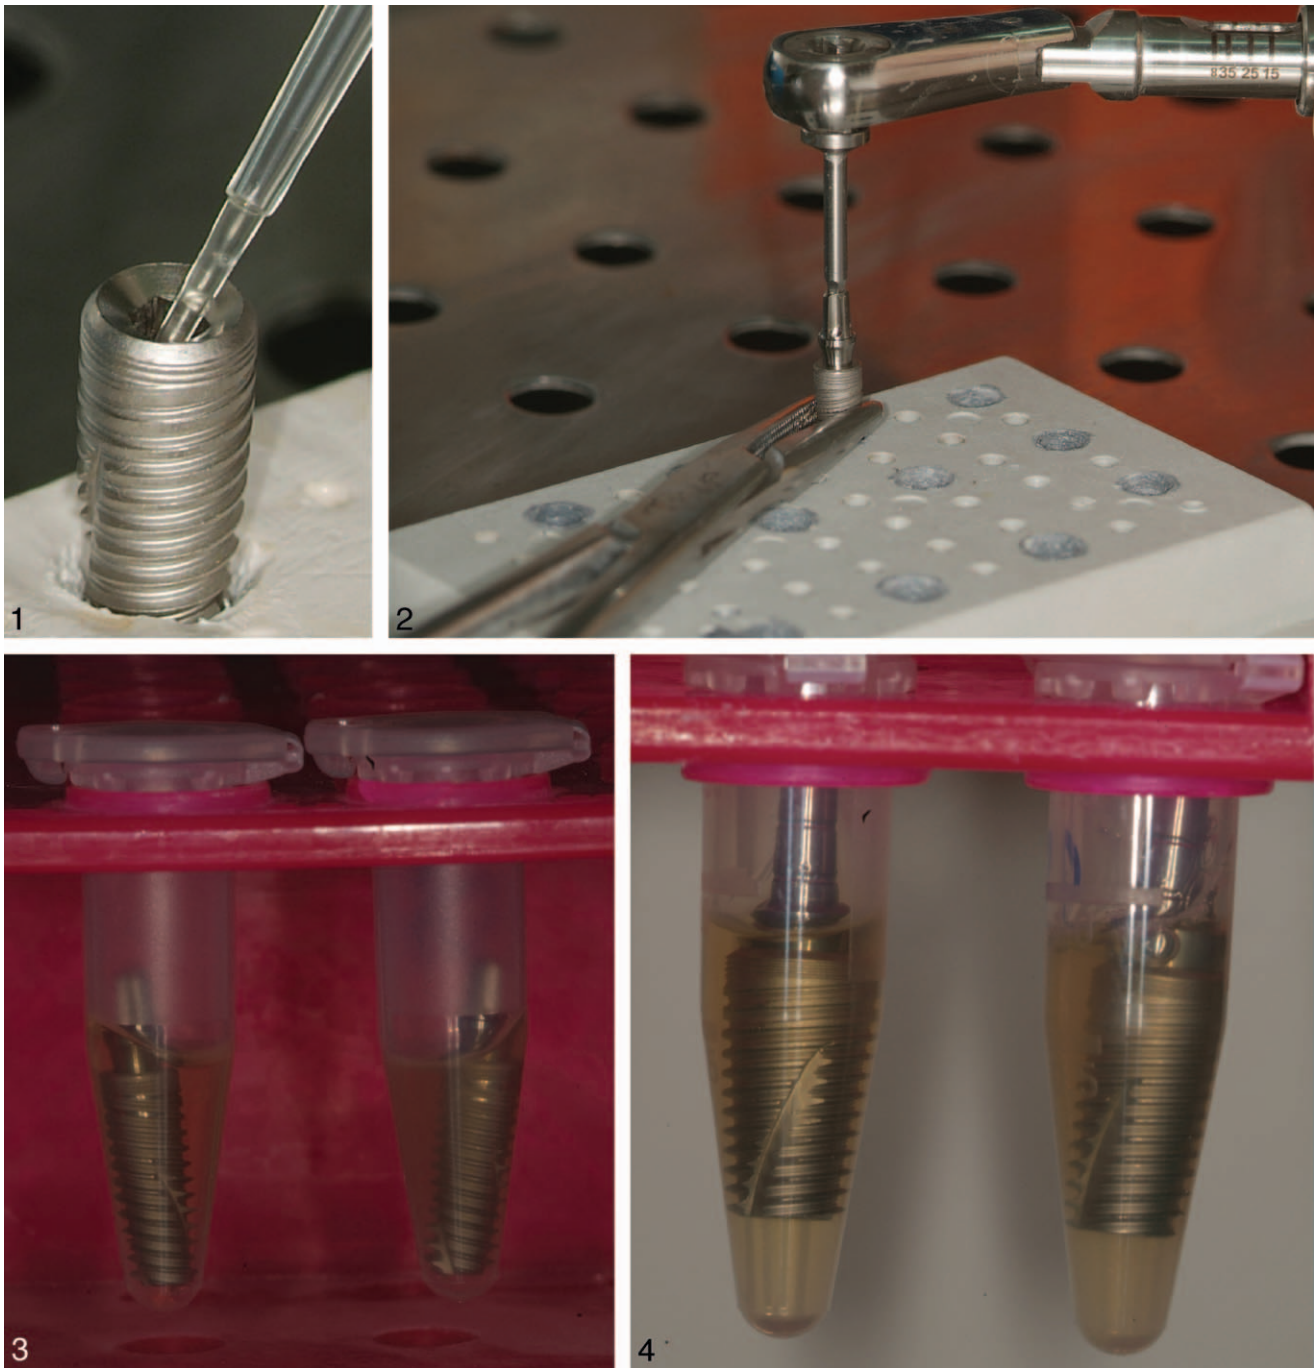
FIGURES 1–4. **FIGURE 1.** The inner part of implants inoculation with a viable bacteria suspension. **FIGURE 2.** An assembled implant-abutment with an implant torque controller. **FIGURE 3.** Cone Morse implants placed into nutrient solution. Left: no contamination. Right: turbidity of the broth as sign of bacterial penetration. **FIGURE 4.** The internal hexagon implants placed into nutrient solution. Left: no contamination. Right: turbidity of the broth as sign of bacterial penetration.

In the present study, Cone Morse implants 4.25×15 , with a universal 3.30×4 cm abutment, and internal hexagon (HI) implants 6×15 , with a fixed-air HI 5.00×2.00 abutment (Dentoflex, São Paulo, Brazil) were used. Ten specimens of each group were tested in the microbiological experiment. After several trials, $0.1 \mu\text{L}$ was determined to be the ideal quantity of bacterial suspension for inoculation in all implant systems.

In the Cone Morse implants, bacterial contamination was found in 3 out of 5 implant-abutment assemblies seeded with the PS, all on the 22nd day. In the assemblies seeded with AA, the contamination was found in 2 samples out of 5, respectively on the 22nd and 24th days. The total of leaked assemblies in this group was 5 out of 10 assemblies. In the internal hexagon implants, bacterial contamination was found in 4 out of 5 implant-abutment assemblies seeded with the PS, respectively 1 assembly on the 13th day, and 3 assemblies on the 21st day. In the assemblies seeded with AA, the contamination was found in all 4 samples, respectively on the 8th, 16th, 21st, and 24th days. The total of leaked assemblies in this group was 8 out of 10 (Table). All the test tubes were examined until the 28th day because none of the assemblies showed contamination of the outer part of the implant. The positive control remained positive. The negative control remained negative.
