Evaluation of Microgap Size and Microbial Leakage in the Connection Area of 4 Abutments With Straumann (ITI) Implant

Mansoor Rismanchian^{1*}
 Mahnaz Hatami²
 Hamid Badrian³
 Navid Khalighinejad³
 Hossein Goroochi³

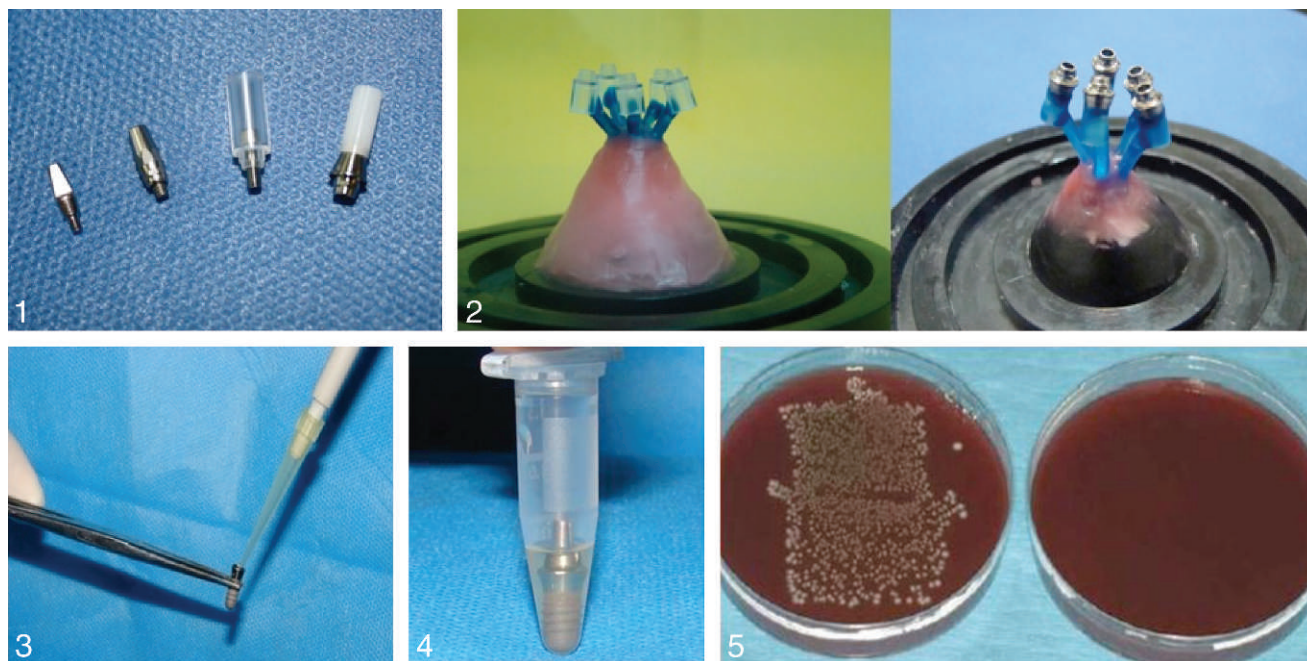
FIGURES 1–5. **FIGURE 1.** Solid, Synocta, Cast On, and Castable abutments. **FIGURE 2.** Cast On and Castable abutments connected to cylinders. **FIGURE 3.** Inoculation of 0.5 μL of bacterial suspensions into implant. **FIGURE 4.** Abutment in TSB culture. **FIGURE 5.** Colony growth on blood agar culture.

platform diameter of 4.8 mm) divided into 4 distinct groups, each containing 9 samples using 4 different types of abutment: Solid, Synocta, Cast On (Straumann, Basel, Switzerland), and CastableRhein (Rhein 83, Bologna, Italy) casted with high noble alloy (Figure 1).

Selected alloys must also meet ISO 1562 and ISO 9693 standards. The alloys used in this study (Degubond 4), based on ADA standards, were high noble alloys and also qualify for ISO 1562 and ISO 9693; therefore, it was consonant with manufacturer criteria. Both groups of castable abutments (including Cast On abutments and 1 group of Castable abutments) were connected to cylinders according to the manufacturer's instruction (Figure 2).

Each implant was fixed with a hemostat so that 0.5 μL of bacterial suspensions with delicate micropipette was inoculated into its inner space (Figure 3). Afterward, the abutments of each group were installed with a special torque range of the ITI system and a force of $35\ \text{N}/\text{cm}^2$. To make sure that the outer surface of the implant-abutment complex did not get polluted during work, sterile cone-shaped paper covers were put on the complex, and sampling was done. Each of the cone-shaped paper covers was soaked in 5 mL of nutrient broth and incubated at 37°C to diagnose probable superficial pollution of samples during working.

All samples were put into Eppendorf microtubes, and TSB culture (Figure 4) was added so that the surface of the culture was located below the abutment's access space. Each group was coded from 1 to 9. In addition, the 50 μ L of culture around the implants was replaced every 12 hours.

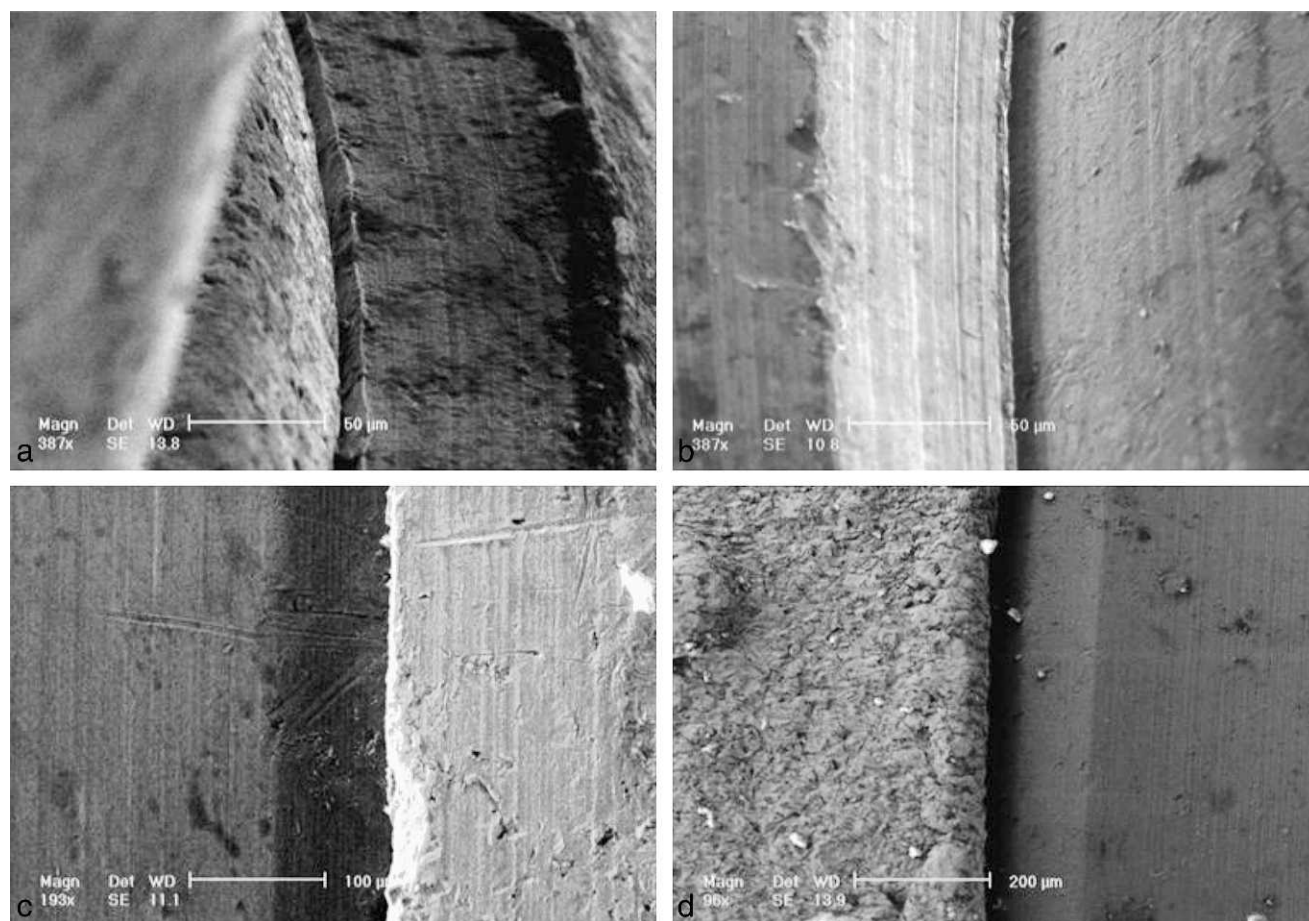
FIGURE 6. Scanning electron microscope images of the contact area between implants and abutments. (a) Synocta abutment-ITI implant contact area. (b) Solid abutment-ITI implant contact area. (c) Cast On abutment-ITI implant contact area. (d) Castable abutment-ITI implant contact area.

Scanning electron microscope (SEM) images are available in Figure 6. After completion of microbiological tests, all samples were placed into ultrasonic equipment (Golten/Whaledent, Mahwan, NJ) and then sterilized in an autoclave. Using the gold sputtering equipment (Bal-Tec, Hayloft, Germany), the power-conducting quality of the samples was measured under the mechanism of physical vapor

disposition with definite time, and at the final step, each sample's microgap was assessed with an electron microscope (Philips x120, Netherland, Eindhoven) at an appropriate voltage (15 kV). The tests were then pursued with proper voltage (15 kV) with an electronic microscope (Phillips) in the next step. The size of the microgap at 4 points in each sample (which were selected randomly) was assessed and compared with the number on a scale bar, determining a proportion.

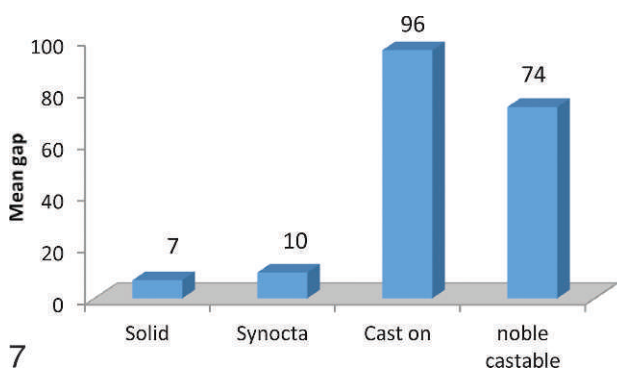
FIGURES 7 AND 8. FIGURE 7. A comparison between the mean microgaps of abutments and ITI implants. FIGURE 8. The mean number of leaked colonies in 4 groups during the study.

One-way variance analysis showed that there is a significant difference in the mean microgap between the different groups of abutments in this study ($P < .001$). Cast On abutments showed the highest and Solid abutments showed the lowest mean microgap. The average amount and standard deviation of the microgap between ITI implants and 4 different types of abutments are reported in Table 1, and a 2-by-2 comparison of these abutments' microgap is reported in Table 2. A comparison between the mean microgaps of abutments is illustrated in Figure 7.
