Root causes of failures in sustainable urban drainage systems (SUDS): an exploratory study in 11 municipalities in the Netherlands

ABSTRACT

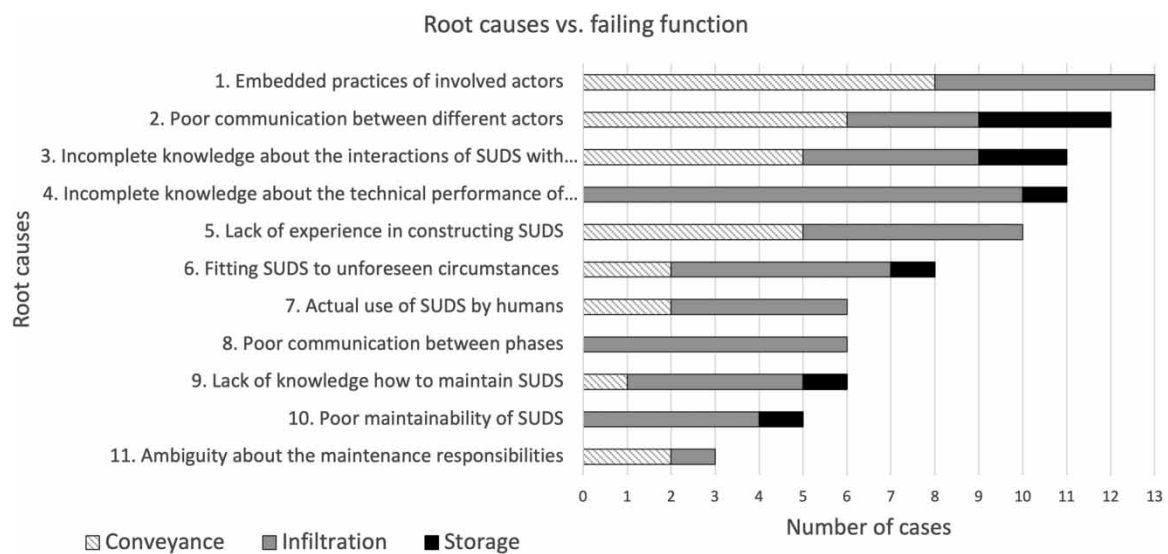
Figure 8 | Number of failures in SUDS of a certain failing function for each root cause.

Figure 8 gives for each of the root causes a breakdown of the number of cases by the different hydraulic functions of SUDS (*conveyance*, *infiltration*, and *storage*). This reveals that the different SUDS types are not equally affected by the root causes.

On the one hand, Figure 8 shows that 10 out of the 11 root causes have been assigned to more than one of the SUDS' functions, illustrating that root causes are not necessarily function-specific. On the other hand, Figure 8 reveals that some causes were frequently assigned to particular types of systems, while these causes were not (or not often) identified for the other systems. This suggests that there is a relationship between specific root causes and the hydraulic principles of SUDS (i.e., infiltration systems process storm water by means of infiltration, and conveyance systems process water through draining it via above-ground structures).

Based on this information, specific recommendations for each of the system types could be made. For example, root cause 4, *incomplete knowledge about the technical performance of SUDS*, is the most common root cause for infiltration systems ($n = 10$), while this root cause has not been assigned to conveyance systems (and has only

been assigned to one failing storage system). Hence, information on technical performance is of particular importance for infiltration SUDS.

In addition, Figure 8 shows that the root causes 1, 2, 3, and 5 (respectively, *embedded practices of involved actors*, *poor communication between different actors*, *incomplete knowledge about the interaction of SUDS with other urban systems*, and *lack of experience in constructing SUDS*) are the most common root causes for failing conveyance systems. These four root causes are all related to the interaction and involvement of non-water-related actors, suggesting that the performance of conveyance SUDS is dependent on the actions of other actors. Conveyance systems process storm water through above-ground drainage and therefore interact with many other infrastructures in the urban environment (e.g., roads, curbs, gardens, speed bump, and lampposts), as well as their responsible actors. This suggests that, to minimize failures in conveyance systems, both the physical and socio-institutional interfaces between SUDS and other urban systems deserve extra attention.
