Root causes of failures in sustainable urban drainage systems (SUDS): an exploratory study in 11 municipalities in the Netherlands

ABSTRACT

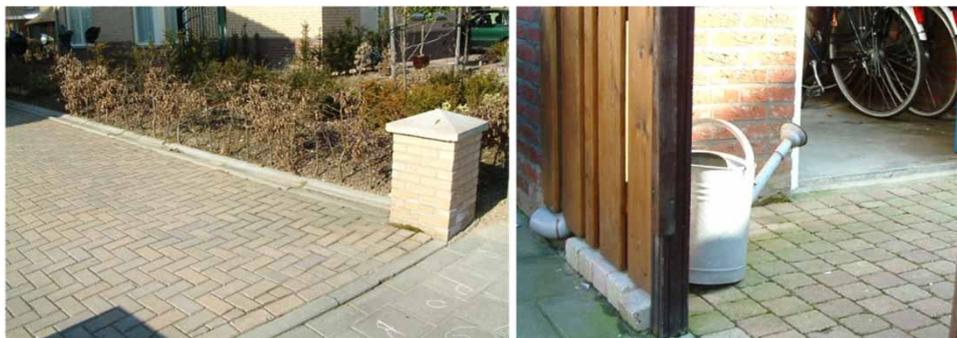
Figure 1 | Two cases (#13 and #15) of technical failures in SUDS with a failing function of conveyance. Left: an obstacle interferes with the transport of water by an open gutter. Right: due to insufficient slope of the garden, the storm water flows into the shed.

- *Conveyance*: The most common technical failure identified for conveyance systems was *Interference with obstacle* (7 out of 25 cases) (see Figure 1 for an example). This technical failure was previously mentioned by Boogaard *et al.* (2006). The second most common failure is *Insufficient slope* (4 out of 25 cases), which is also in line with previous studies (Boogaard *et al.* 2006; Pötz 2016).

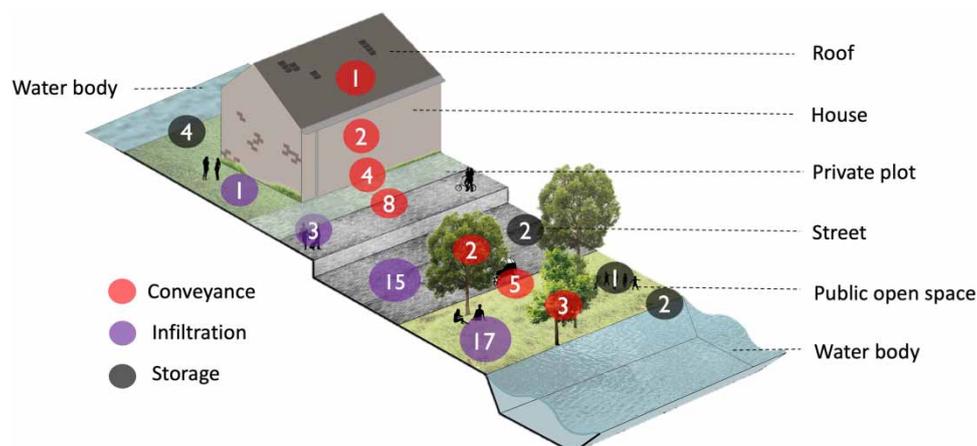
**Figure 2** | Overview of the number of technical failures of SUDS that occur at different locations in the urban area. The colors indicate the hydraulic functions of the SUDS.

refers to failures occurring at the physical interface between two systems. See [Figure 2](#) for an illustration of the failure locations per type of SUDS.

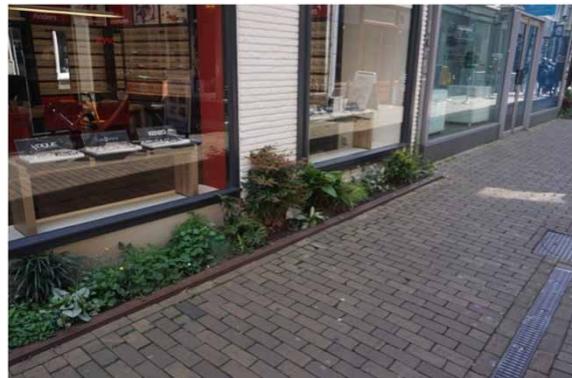
Figure 3 | Case #30: a facade garden, which has been assigned the root cause embedded practices of involved actors. A facade garden is typically constructed surrounded by raised borders. Preventing runoff to be drained into the garden, this reduces the effectiveness of the SUDS.

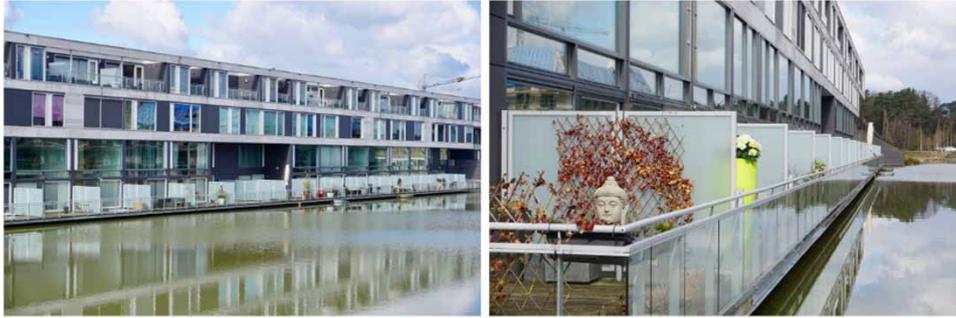
Figure 4 | Case #60 has been assigned the root cause poor communication between different actors. Due to lacking communication between the architect and the municipality, the houses were built only 0.15 m from the water level. This minimized the storage capacity of the surface water, while the water was initially designed as a storm water detention pond with a freeboard of 0.70 m.

An example of such poor communication leading to malfunctioning SUDS is illustrated in Figure 4. The interviewee explained that architects typically want to minimize the distance between the ground-floor level of the house and the water level (in this case 0.15 m), aiming for a closer connection with the water – a so-called ‘living-on-water-experience’. The municipality, however, generally designs water systems with a large freeboard

(in this case 0.70 m) to increase the storage capacity of the water, which could prevent urban flooding after heavy rainfall, as well as water shortage in case of drought. These requirements, however, were not communicated clearly in the decision-making process, which eventually resulted in the houses being constructed with little freeboard. As the storage capacity now had to be realized elsewhere in the urban water system, this brought along high costs.

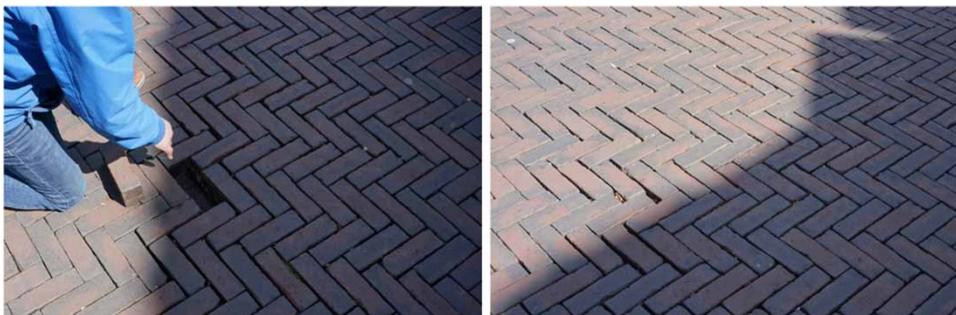
Figure 5 | Case #29 has been assigned the root cause *Incomplete knowledge* about the interactions of SUDS with other urban systems. Due to the impact of cars as well as street sweeping, the joints of the permeable pavement bricks vanished. This decreased the overall performance of the SUDS, i.e., the stability of the road surface.

Figure 5 presents an example of the unexpected impact of car traffic on the performance of permeable pavement. After the implementation of the pavement, it turned out that car traffic resulted in friction between the stones. This damaged the joint fillings between the bricks and eventually led to their disappearance. As the practitioners had no experience with permeable pavement yet, they did not anticipate the long-term effects of cars on this type of porous pavement construction.

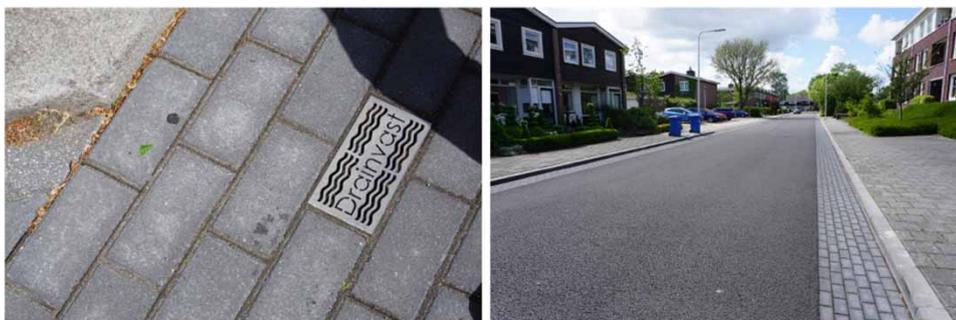
Figure 6 | Case #33 has been assigned the root cause *Incomplete knowledge* about the internal technical processes. The pavers were separated by joints filled with a permeable material, allowing water to infiltrate. Even after a small rainfall event, however, water remained ponding for at least 1 h. As such, it was thought that the permeable material had become clogged, leading to a malfunction of the SUDS.

explained that this incomplete knowledge typically stems from the limited monitoring that is carried out in SUDS. They argued this prevents learning and results in unnecessary failures. In addition, one interviewee reported that in some cases, designers do not have the knowledge and/or experience to properly understand the internal processes occurring in SUDS. This relates, for example, to incomplete knowledge about the subsoil. As compared with sewers, the subsoil forms an important part of SUDS, particularly in the case of infiltration facilities. The design is then often based on the very limited information available about the subsoil, if at all. When SUDS are then constructed in practice, the subsoil sometimes has other characteristics than expected, resulting in malfunctions. For instance, the soil contains more clay, or groundwater levels are higher than expected, decreasing the permeability of the soil, or reducing the subsurface storage capacity, respectively. An example is provided in [Figure 6](#).

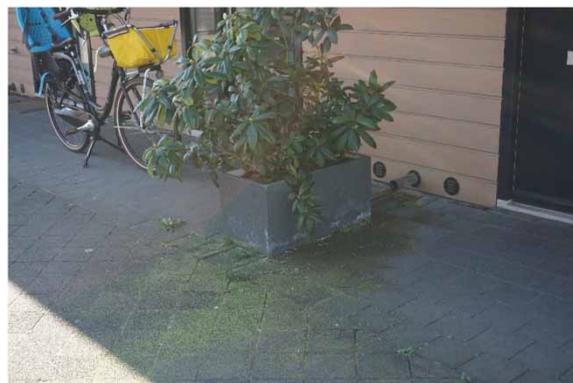
Figure 7 | Case #8 has been assigned the root cause actual use of SUDS. A flowerpot was placed in front of a dwelling's water outlet, preventing water to be discharged properly.

They could, for example, put a flowerpot in the gutter (Figure 7). The rain pipe collects the storm water from the roof and discharges the storm water into the gutter at street level. The water is then transported overland, and thus kept visibly (as opposed to the traditional subsurface lateral house connection), toward the infiltration facility. When placing a flowerpot in the gutter, the intended flow path of the storm water is blocked.

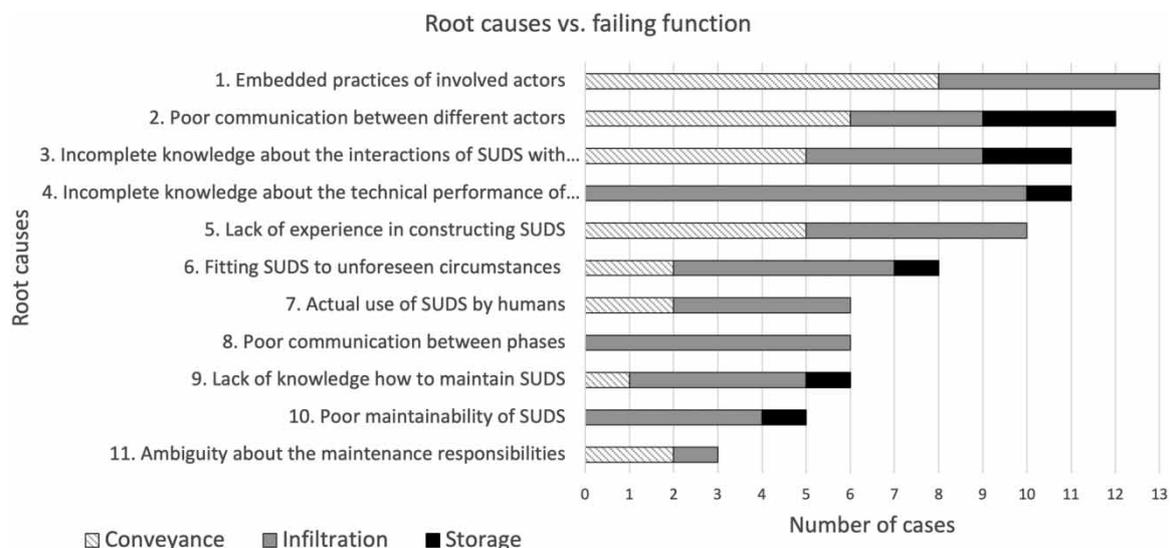
Figure 8 | Number of failures in SUDS of a certain failing function for each root cause.

[Figure 8](#) gives for each of the root causes a breakdown of the number of cases by the different hydraulic functions of SUDS (*conveyance*, *infiltration*, and *storage*). This reveals that the different SUDS types are not equally affected by the root causes.

On the one hand, [Figure 8](#) shows that 10 out of the 11 root causes have been assigned to more than one of the SUDS' functions, illustrating that root causes are not necessarily function-specific. On the other hand, [Figure 8](#) reveals that some causes were frequently assigned to particular types of systems, while these causes were not (or not often) identified for the other systems. This suggests that there is a relationship between specific root causes and the hydraulic principles of SUDS (i.e., infiltration systems process storm water by means of infiltration, and conveyance systems process water through draining it via above-ground structures).

Based on this information, specific recommendations for each of the system types could be made. For example, root cause 4, *incomplete knowledge about the technical performance of SUDS*, is the most common root cause for infiltration systems ($n = 10$), while this root cause has not been assigned to conveyance systems (and has only

In addition, Figure 8 shows that the root causes 1, 2, 3, and 5 (respectively, *embedded practices of involved actors*, *poor communication between different actors*, *incomplete knowledge about the interaction of SUDS with other urban systems*, and *lack of experience in constructing SUDS*) are the most common root causes for failing conveyance systems. These four root causes are all related to the interaction and involvement of non-water-related actors, suggesting that the performance of conveyance SUDS is dependent on the actions of other actors. Conveyance systems process storm water through above-ground drainage and therefore interact with many other infrastructures in the urban environment (e.g., roads, curbs, gardens, speed bump, and lampposts), as well as their responsible actors. This suggests that, to minimize failures in conveyance systems, both the physical and socio-institutional interfaces between SUDS and other urban systems deserve extra attention.

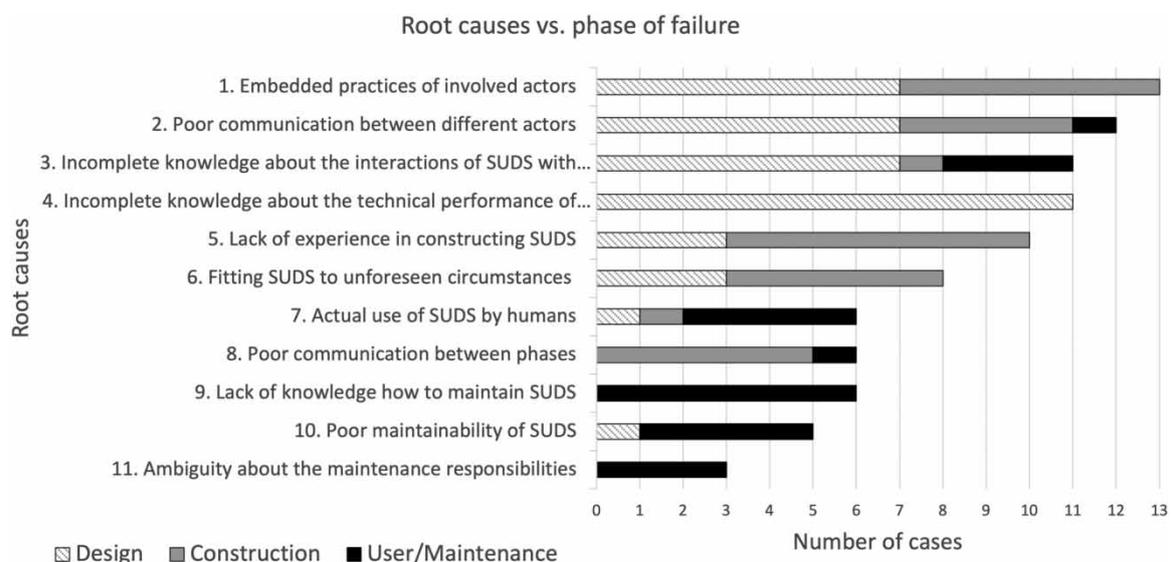
Figure 9 | Number of failures that origin from each of the project phases, per root cause.

With respect to the failures originating from the user and maintenance phase, Figure 9 reveals that the most dominant root causes are 7, 9, and 10: *Actual use of SUDS*, *lack of knowledge how to maintain SUDS*, and *poor maintainability of SUDS*, respectively. All these root causes relate to a certain lack of knowledge from users and operators on how to handle SUDS. Actors in charge of maintenance have to be well involved such

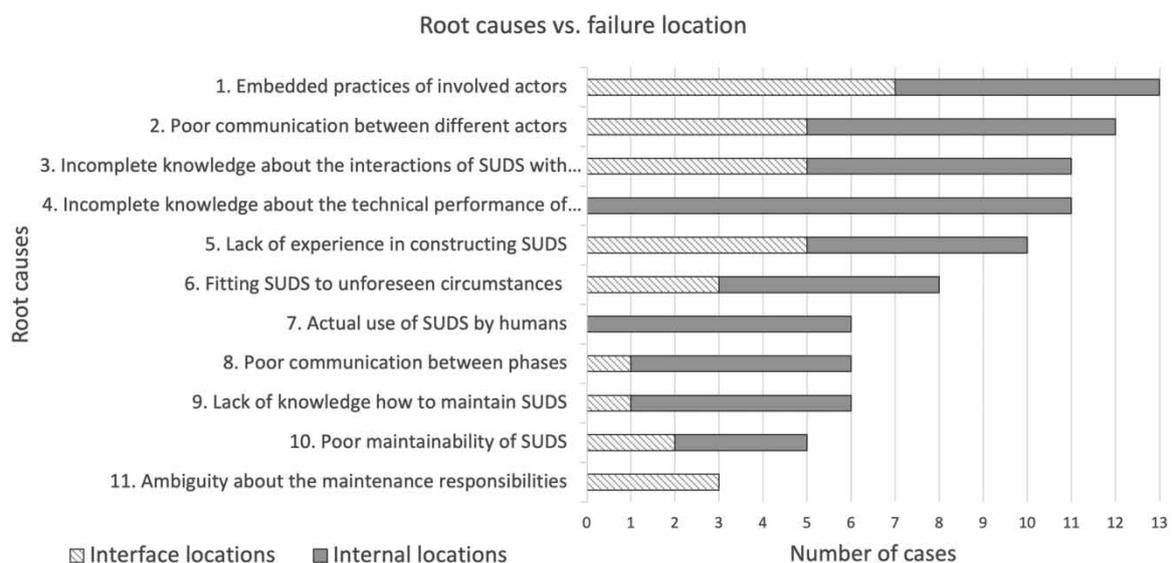
Figure 10 | Number of failures in SUDS failure location, for each root cause.
