# Factors in the design of an urban microbat flyway

Arthur W. White

Biosphere Environmental Consultants Pty Ltd, 69 Bestic Street, Rockdale, NSW 2216  
Email: larthur@tpg.com.au

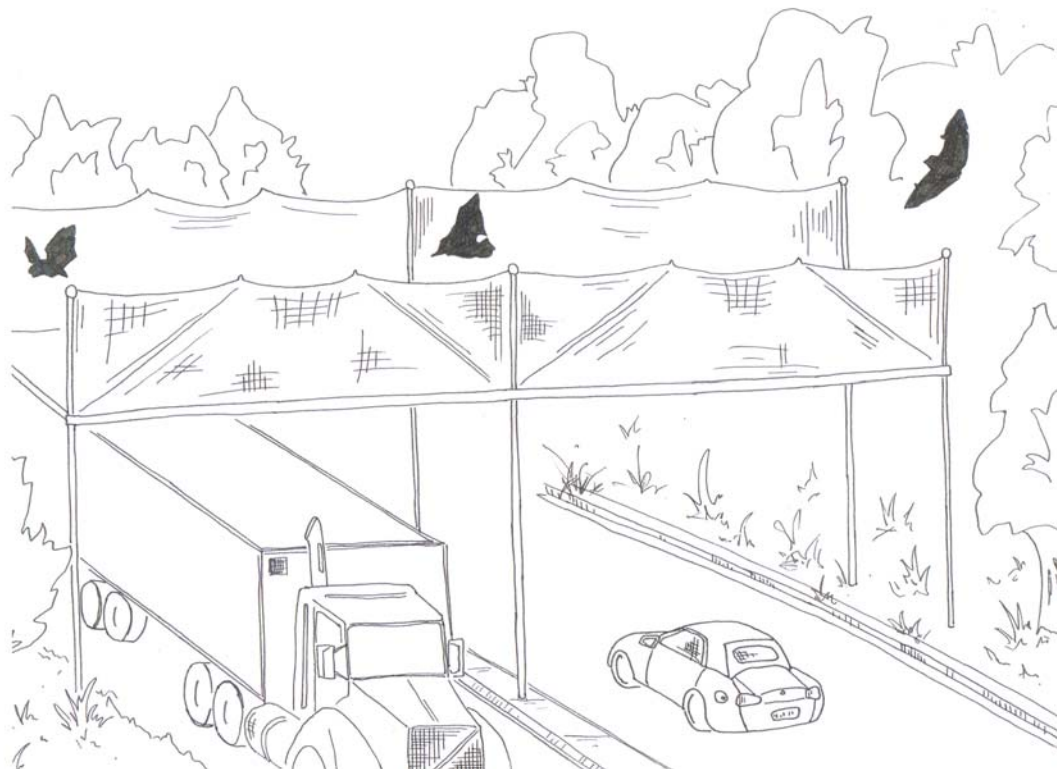
Figure 3 Artist's impression of the bat fly-over across the Pacific Highway at Artarmon.

One location on the Pacific Highway, near Moriarty Street at Artarmon, appears suitable for the crossing. The buildings are only two stories high and there are no multi-storey buildings nearby. The crossing would need to be a suspended, flyover bridge that could be lightweight and relatively inconspicuous. To reduce the

cost of the fly-over bridge, the main structural material could consist of suspended dense cloth (or synthetic material). The material would need to be strong enough to withstand strong wind, rain and UV light exposure. The flyover bridge would have two vertical walls and a floor but no roof. The crossing would need to be at least three metres wide and have side that extended vertically 2 to 3 metres above the floor. The structure could be suspended from supporting cables that span the highway at a height of about 5 metres. The cost of the structure could be met by the sale of advertising space on the outside of the fly-over bridge: if advertising is placed on the outer wall, associated night lighting would need to be directed downwards and not illuminate the interior of the bridge at night.
