Prefabricated Zirconia Crowns – A Solution to Treat Hypomineralized Permanent Molars: Report of a Case

Jorge Casián-Adem*/ Lizette Cobos ** / William F Waggoner ***/ Anna B Fuks ****

A clinical case of a 13-year-old female patient is presented. She had a mandibular second permanent molar that demonstrated significant caries and loss of much of the clinical crown, which was treated with a vital pulpotomy and restored with a prefabricated zirconia crown.

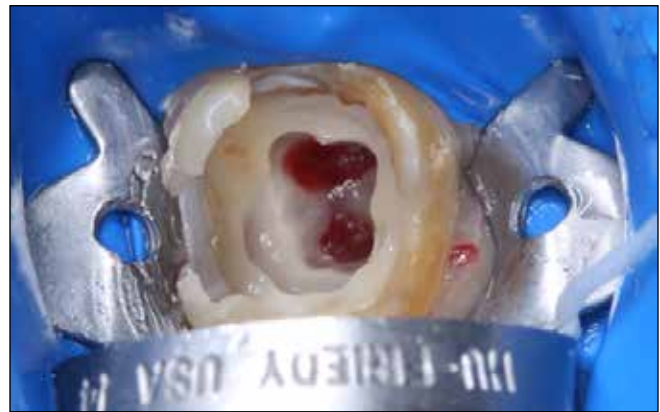
Figure 2. Occlusal view of the pulpotomy.

a low-speed #6 carbide round bur, the carious tooth structure was carefully excavated. This, however, lead to a carious exposure of the pulp, which was found to be vital. As this was a young, permanent molar it was decided to treat the pulp with an MTA vital pulpotomy. (Figure 2).

The coronal pulp was removed and a wet cotton pellet moistened with a 1.25% solution of sodium hypochlorite was placed on the pulp stumps for approximately 1 min. The pulp chamber was then rinsed with sterile saline solution. A portion of Mineral Trioxide Aggregate cement (NeOMTA; NuSmile, Ltd, Houston, TX. USA) was mixed following the manufacturer’s instructions to a putty-like consistency. The MTA was placed into the pulp chamber with an amalgam carrier and was gently condensed with a wet cotton pellet. The MTA was then covered with a 2-3mm layer of resin-modified glass ionomer cement (BioCem; NuSmile, Ltd, Houston, TX. USA) to protect the MTA during the subsequent process of tooth preparation and crown placement.

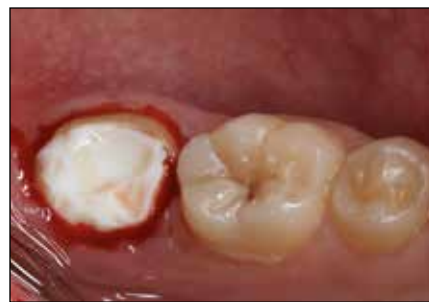
Figure 3. Preparation performed on the mandibular second molar.

Preparation for the zirconia crown was done as conservatively as possible. This consisted of occlusal reduction of approximately 1.5 mm; and circumferential reduction of 1-1.5mm, removing all surface convexity, with a gingival feather-edge margin extending approximately 1.5 mm subgingivally. (Figure 3) As this was a molar in an active process of eruption it was desired to place the gingival margin at a depth that would remain subgingival at the completion of eruption.

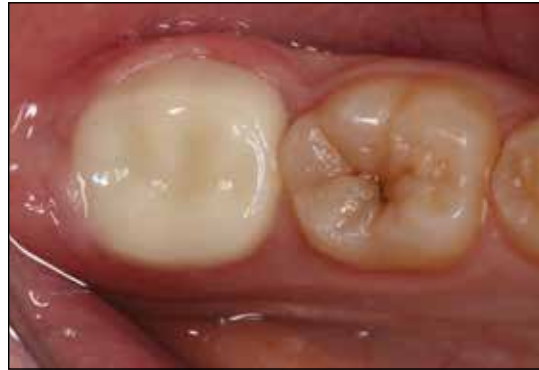
One week later the tooth was reassessed. Tooth sensitivity had completely disappeared, the gum around the crown was healthy, and the patient was very pleased with the treatment, reporting that she was able to eat, chew, and brush her teeth in a normal manner (Figure 5).

Figure 5. Photograph of the crown 1 week after cementation. The crown appears clean, the gingival tissue is healthy, and tooth sensitivity has disappeared.

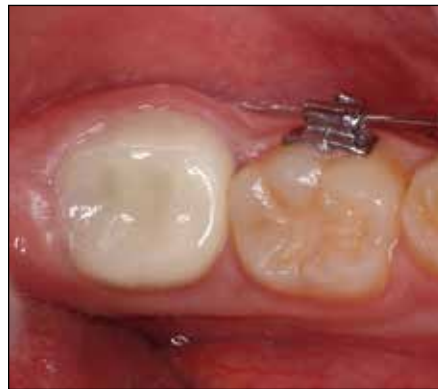
Fourteen months later, the patient initiated orthodontic treatment in the same dental office, allowing for continued follow-up of the tooth. At 40 months post-operatively the crown had retained its esthetics and function and the tooth had remained vital and asymptomatic. (Figures 6 and 7)

Figure 6. Follow-up at 40 months after crown placement. The tooth is asymptomatic and the gingival tissue appears healthy.
