Correction of a Class III Malocclusion with All-on-4 Concept Implant Supported Full Mouth Rehabilitation

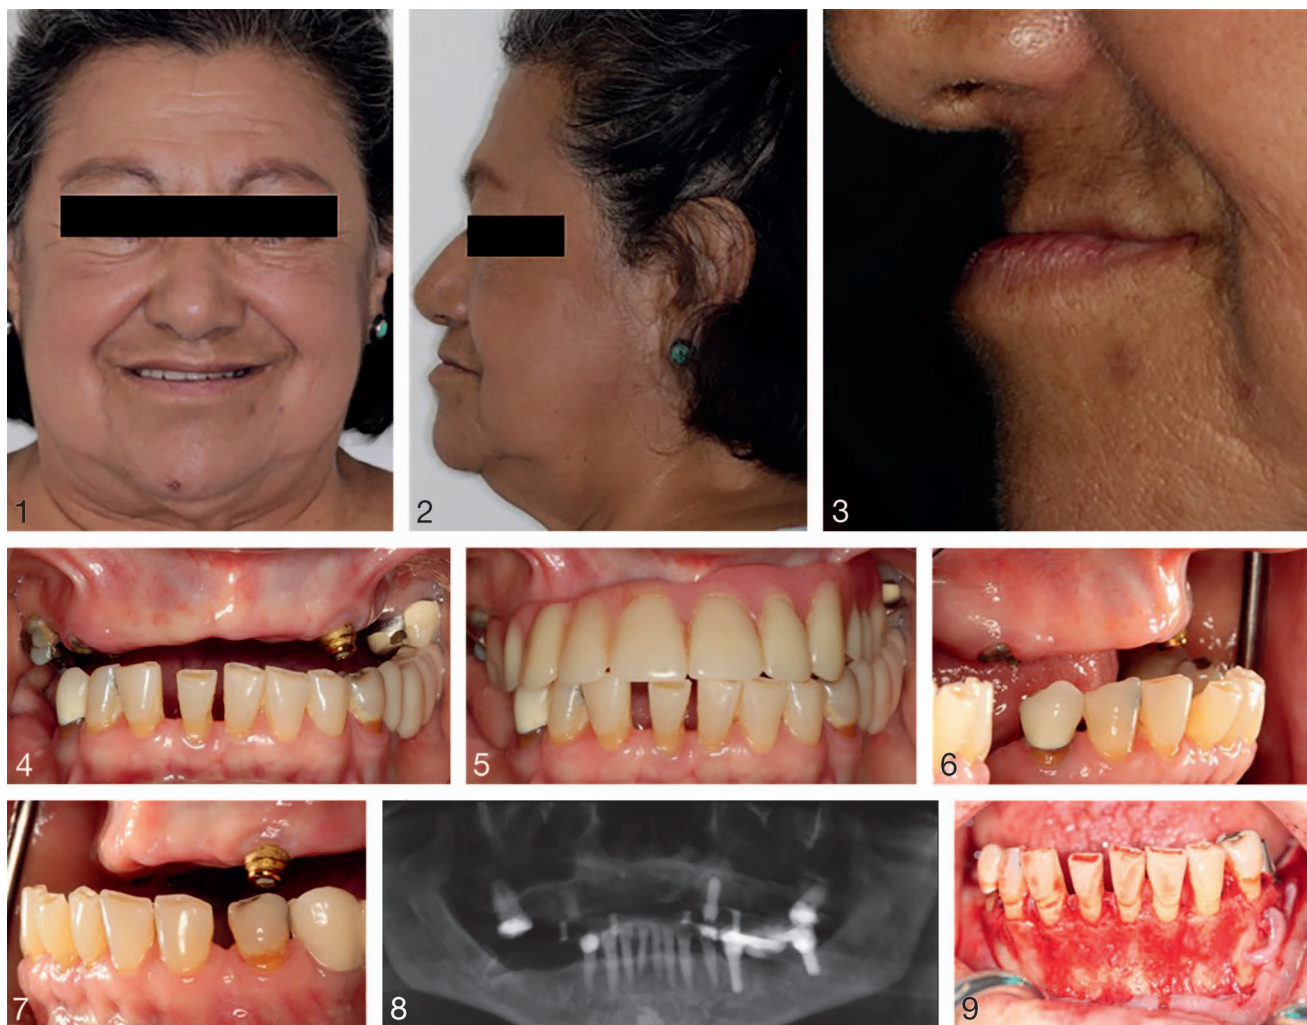
FIGURES 1–9. **FIGURE 1.** Facial frontal view (preoperative) showing accentuated folds, which is a sign for lack of adequate labial support. **FIGURE 2.** Facial profile view (preoperative) showing collapsed vertical dimension of occlusion. **FIGURE 3.** Closeup, side smile view (preoperative) showing lack of adequate upper lip support. **FIGURE 4.** Intraoral full frontal (preoperative) in maximum intercuspation without the removable partial denture showing lack of restorative space. **FIGURE 5.** Intraoral full frontal (preoperative) in maximum intercuspation with the removable partial denture showing the denture teeth without an ideal setup. **FIGURE 6.** Intraoral right lateral view (preoperative) in maximum intercuspation showing significant Class III malocclusion. **FIGURE 7.** Intraoral left lateral view (preoperative) in maximum intercuspation showing significant Class III malocclusion. **FIGURE 8.** Panoramic radiograph (preoperative) showing significantly pneumatized sinuses, especially the left maxillary sinus. **FIGURE 9.** Mandibular full-thickness flap elevated before mandibular edentulation.

with a chief complaint of "I cannot wear my upper partial denture, it keeps on breaking." Clinical examination revealed the patient had a reduced VDO, supraeruption of the mandibular teeth, and a lack of restorative space (Figure 1). A profile analysis of the patient's face revealed a skeletal Class III malocclusion (Figures 2 and 3). Clinical examination also revealed the presence of a maxillary implant with a locator attachment present at site #11 and implants at sites #17 and #20 supporting an implant supported fixed partial denture (Figures 4 through 8). Evaluation of the maxillary removable partial denture revealed a fracture in the acrylic at the site of the locator attachment. Tooth #6 was apparently overdentured by the maxillary removable partial denture; however, it was carious and fractured at the gingival level. The patient also reported this fracture and stated it was a recurring problem. Risks, benefits, and alternative treatments were discussed at great length with the patient. The patient opted for maxillary and mandibular All-on-4 concept implant placement,⁸ which was later restored by a titanium/acrylic (hybrid) fixed/detachable implant supported prosthesis.

implants were also placed in the maxilla. Site #3 required an internal osteotome sinus graft⁹ of the right maxillary sinus using Bio-Oss Xenograft. A Zimmer TSV 4.7 × 10-mm implant body was simultaneously placed at the site of #3 with the sinus lift. Zimmer TSV implant bodies 4.1 × 10 mm were placed in sites #7 and #10. Because of a lack of alveolar bone height at the site of #14, a lateral window sinus augmentation was completed on the left maxillary sinus. Xenograft Bio-Oss was used for this sinus augmentation, and the window was covered using Biomend extend.¹⁰ The graft material was allowed to heal for 6 months before the placement of a Zimmer TSV 6 × 10-mm implant body at site #14. During the healing phase, the patient was provided with interim complete maxillary and mandibular dentures.

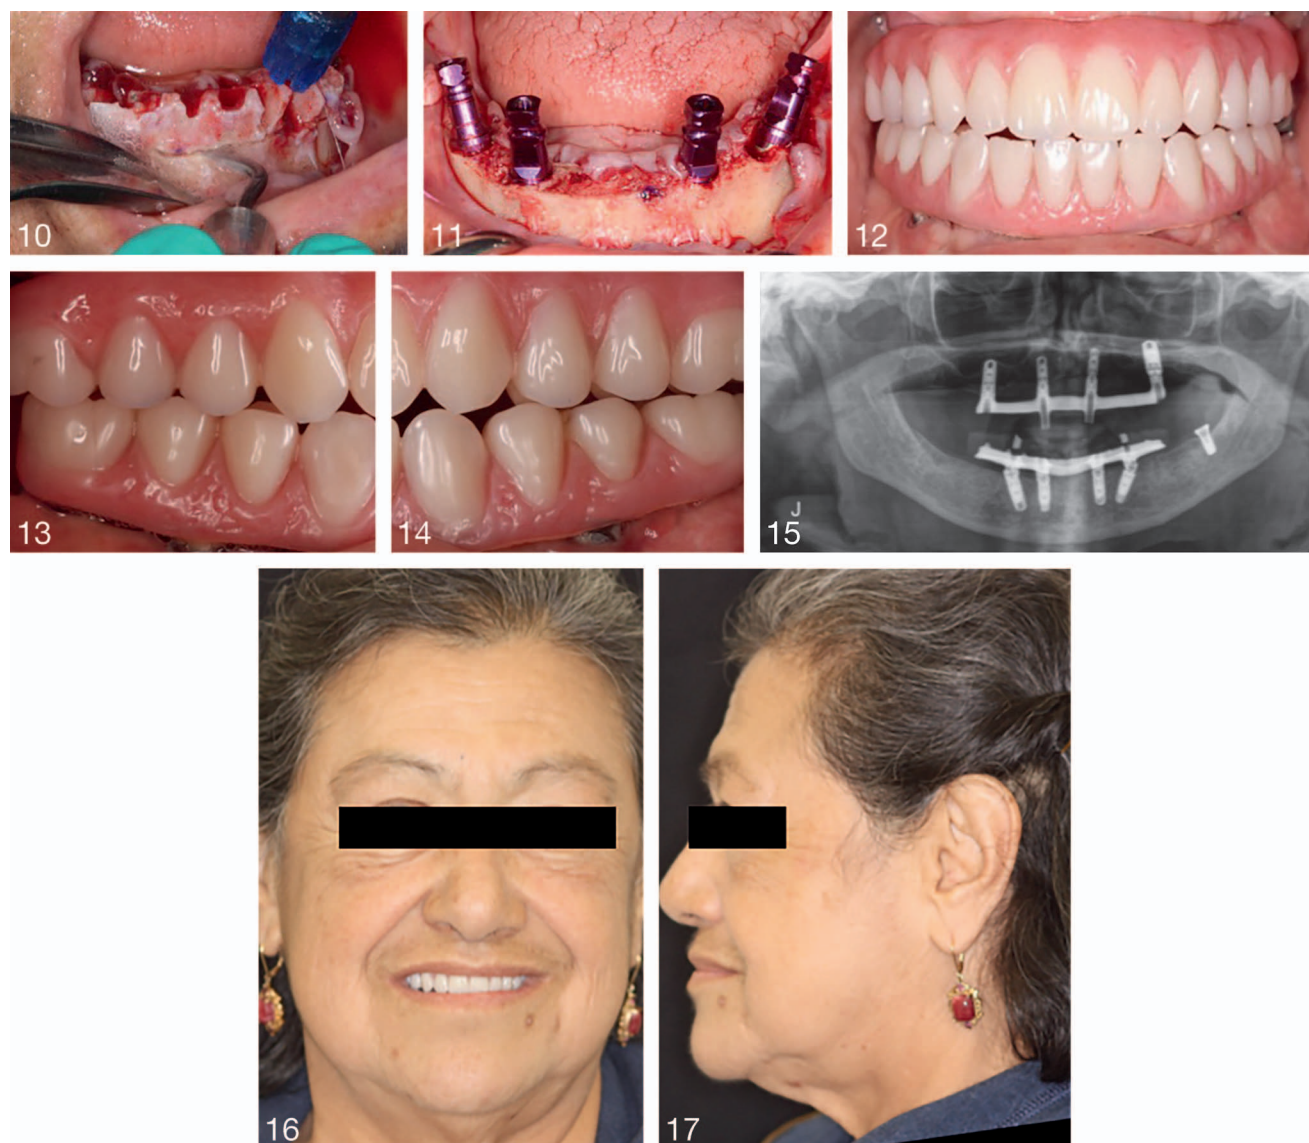
FIGURES 10–17. **FIGURE 10.** Piezotome was used for 10-mm alveoloplasty of the mandibular alveolar ridge to create more restorative space and correction of the Class III malocclusion. **FIGURE 11.** Four Zimmer TSV implants placed in the mandibular arch after 10-mm alveoloplasty. **FIGURE 12.** Full frontal intraoral view (postoperative) in maximum intercuspation showing the maxillary and mandibular screw-retained implant supported fixed prostheses. **FIGURE 13.** Right lateral intraoral view (postoperative) in maximum intercuspation. **FIGURE 14.** Left lateral intraoral view (postoperative) in maximum intercuspation. **FIGURE 15.** Panoramic radiograph (postoperative) showing the maxillary and mandibular implant-supported prostheses. **FIGURE 16.** Facial frontal view (postoperative). **FIGURE 17.** Facial profile view (postoperative) demonstrating restored vertical dimension of occlusion.

For the case presented in this paper, a significant alveoplasty was performed in the mandibular arch after edentulation primarily to gain more restorative space.⁶ The amount of alveoplasty also aided in the creation of the mandibular prosthesis in a proper occlusal relationship with the maxillary prosthesis while maintaining a natural and hygienic pontic surface.⁶ However, before planning for such alveoplasty, assessment of the VDO and centric relation is crucial. VDO assessment was accomplished by the following methods: physiologic rest position, esthetic appearance, and closest speaking space.¹³
