## The South Australian Safe Drinking Water Act: summary of the first year of operation

### ABSTRACT

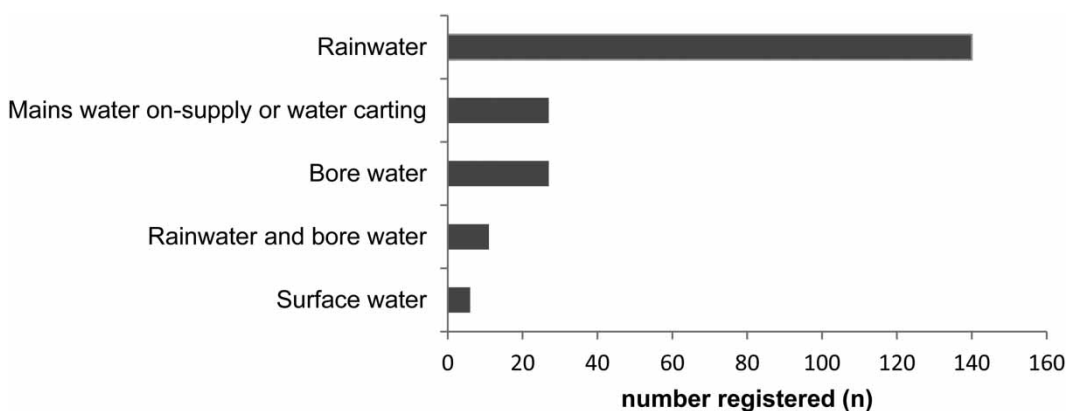
Figure 1 | Water sources used by drinking water providers (excluding SA Water Corporation) registered under the *Safe Drinking Water Act 2011*.

The majority of drinking water providers that registered under the Act sourced drinking water from rainwater (66%,  $n = 140$ ), see Figure 1. On-supply or carting of mains water accounted for 13% ( $n = 27$ ) of the providers, while a further 13% ( $n = 27$ ) were supplied by bore water. A number of providers used multiple sources of drinking water, predominantly rainwater with bore-water backup (5%,  $n = 11$ ). Finally, 3% ( $n = 6$ ) of providers used a surface water supply, from either a dam or the River Murray.

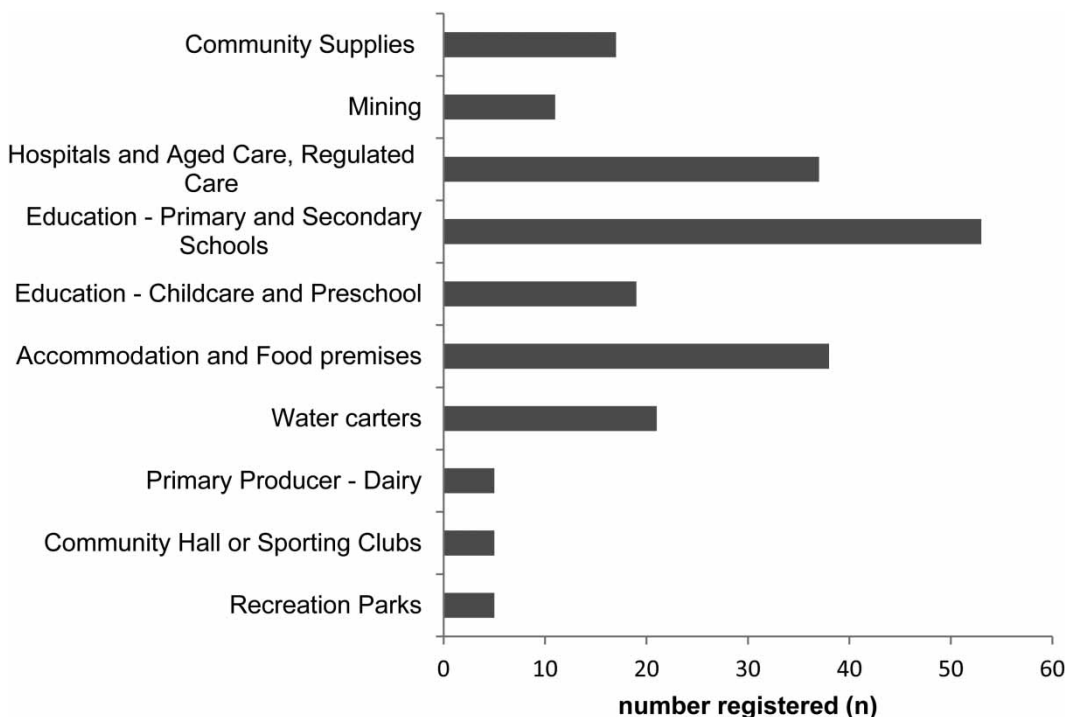
Figure 2 | Drinking water providers, by type, registered under the *Safe Drinking Water Act 2011*.

As shown in Figure 2, schools accounted for 25% (n = 53) of the total drinking water providers registered and included school premises, both public and privately owned, and school camp facilities located in regional areas of the State. All schools used rainwater as the source of drinking water and UV treatment was widely used. For public schools, the policy is to install a UV unit where rainwater is used. For private schools, UV disinfection or routine chlorination was also used for treatment of rainwater. Two of the private schools did not treat the rainwater. A further 18 preschool facilities also registered using rainwater, with UV treatment. One private childcare facility registered using rainwater where a boiled water procedure had been implemented.
