The South Australian Safe Drinking Water Act: summary of the first year of operation

ABSTRACT

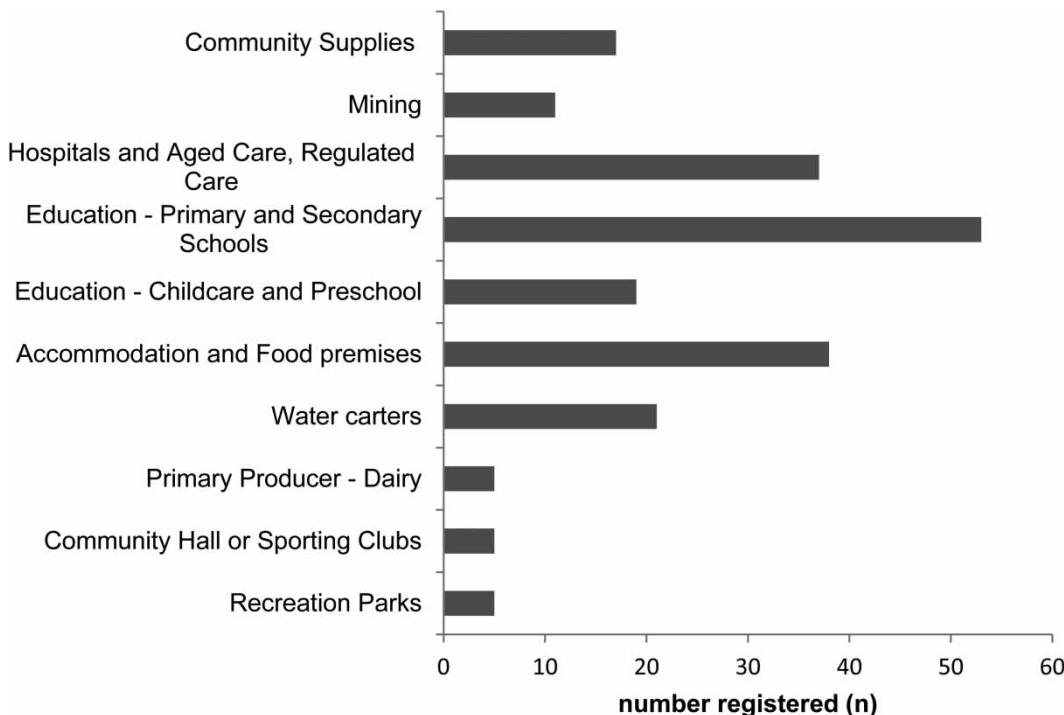
Figure 2 | Drinking water providers, by type, registered under the *Safe Drinking Water Act 2011*.

As shown in Figure 2, schools accounted for 25% (n = 53) of the total drinking water providers registered and included school premises, both public and privately owned, and school camp facilities located in regional areas of the State. All schools used rainwater as the source of drinking water and UV treatment was widely used. For public schools, the policy is to install a UV unit where rainwater is used. For private schools, UV disinfection or routine chlorination was also used for treatment of rainwater. Two of the private schools did not treat the rainwater. A further 18 preschool facilities also registered using rainwater, with UV treatment. One private childcare facility registered using rainwater where a boiled water procedure had been implemented.
