## Faecal contamination of groundwater in rural Vanuatu: prevalence and predictors

### ABSTRACT

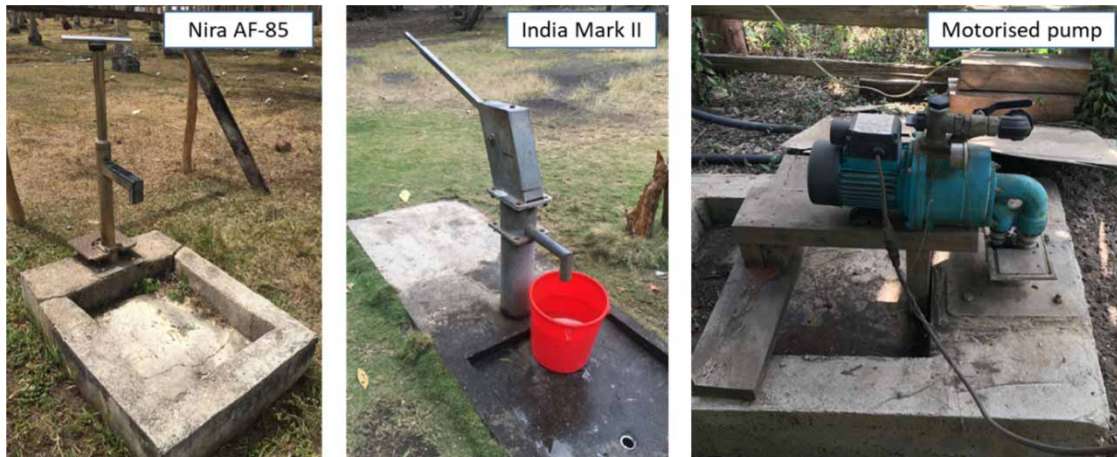
**Figure 2** | Pump types included in the assessment.

This included 124 Nira AF-85 handpumps, seven India Mark II handpumps and 18 motorised pumps (Figure 2). The data collection took place across 11 islands during August and September 2017, which are typically the driest months of the year in Vanuatu. Data from the country's rural water supply inventory were used as the basis for locating the groundwater sources to be included in the study.

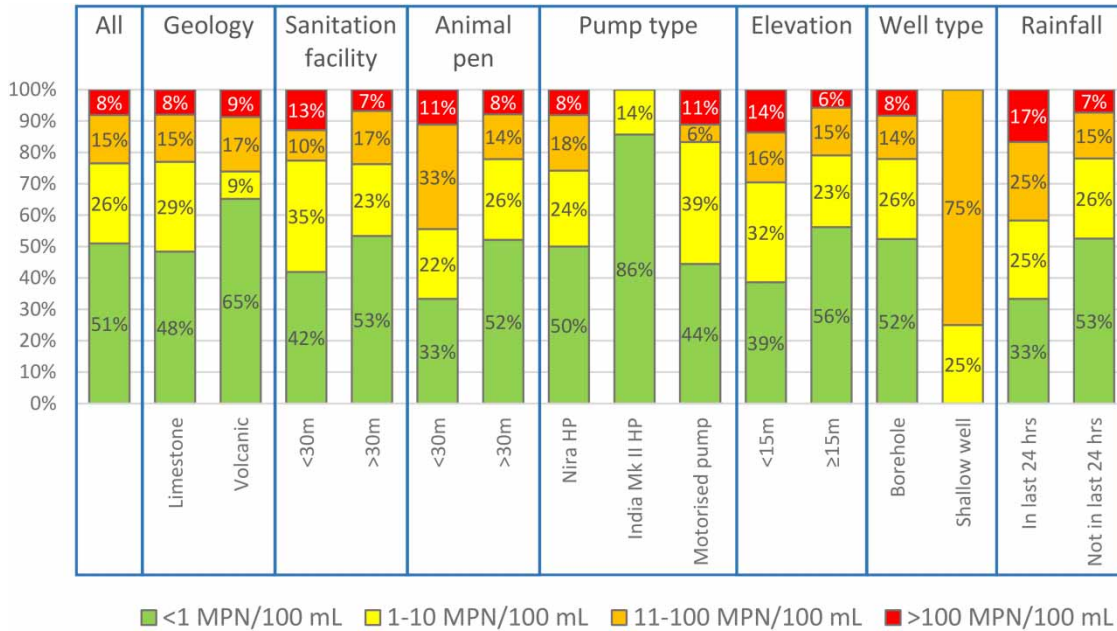
Figure 5 | E. coli concentrations in all groundwater sources.

Overall, *E. coli* was detected in 49% of groundwater sources and 51% for Nira AF-85 handpumps (Figures 5 and 6). The percentage of sources with detectable *E. coli* was higher for systems that were; (i) underlain by coral limestone, (ii) located within 30 m of a sanitation facility or an animal pen, (iii) situated at a lower elevation, (iv) installed on shallow wells, and (v) visited within 24 h of rainfall.
