## Faecal contamination of groundwater in rural Vanuatu: prevalence and predictors

### ABSTRACT

Groundwater is an important source of water for coastal communities in Pacific Island Countries. This study assessed the prevalence and predictors of faecal contamination in groundwater sources across 11 islands in Vanuatu. *Escherichia coli* was detected in 49% of sources and *E. coli* concentration exceeded 10 MPN (most probable number)/100 mL for 23% of sources. When adjusting for other variables, the detection of *E. coli* was significantly associated with severe pump stand corrosion, suggestive of contaminated run-off directly entering boreholes. *E. coli* concentration >10 MPN/100 mL was also significantly associated with: (i) hand-dug wells (as compared to drilled boreholes); (ii) severe pump stand corrosion; (iii) water points underlain by volcanic rocks (as compared to coral limestone); and (iv) rainfall in the previous 24 h. Encasing pump stands in concrete – as some communities had done – was found to have a significant protective effect. While baseline statistics for Sustainable Development Goal target 6.1 suggest that 87% of Vanuatu's rural population have access to at lea

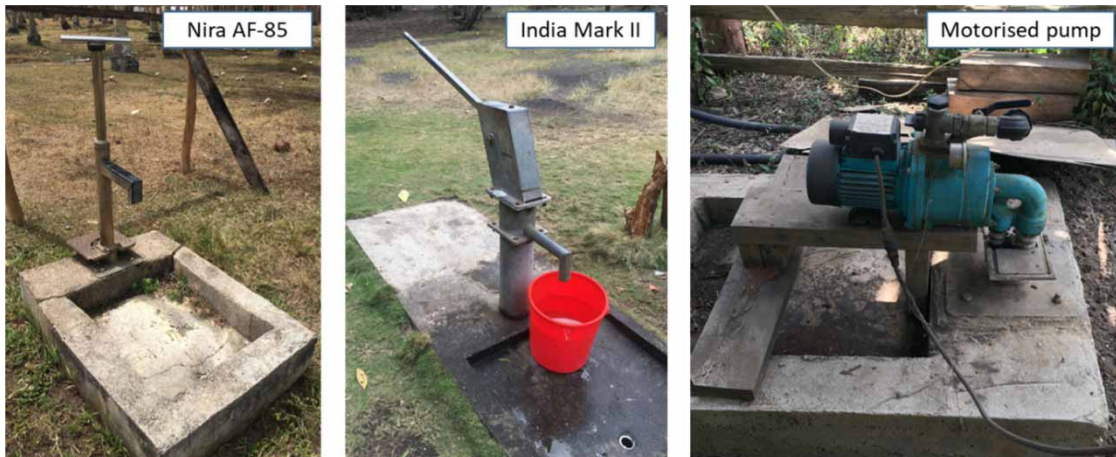
**Figure 2** | Pump types included in the assessment.

This included 124 Nira AF-85 handpumps, seven India Mark II handpumps and 18 motorised pumps (Figure 2). The data collection took place across 11 islands during August and September 2017, which are typically the driest months of the year in Vanuatu. Data from the country's rural water supply inventory were used as the basis for locating the groundwater sources to be included in the study.

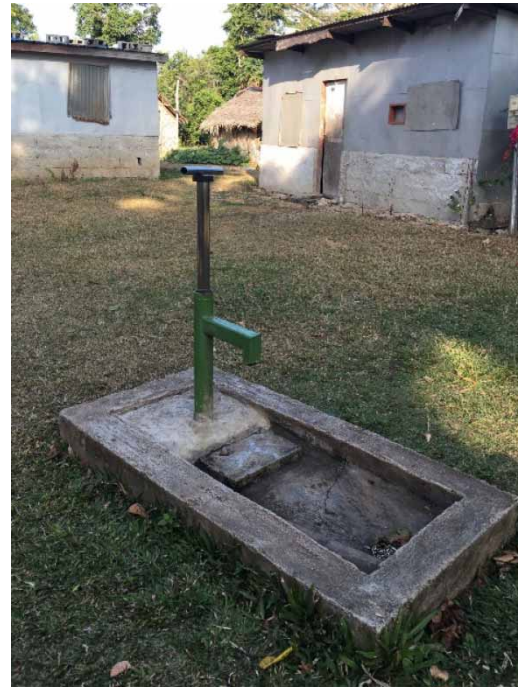
Figure 7 | Example of a Nira AF-85 pump stand encased in concrete.

strong evidence that inadequate maintenance is compromising the safety of drinking water supplied. Almost a third of Nira handpumps had base plates that were significantly corroded or missing altogether, allowing run-off to flow directly into the borehole. With an average age of 17 years, most of the Nira AF-85 handpumps inspected were approaching the end of their expected lifespan of 25–30 years (World Bank 1994). There was a clear link between handpump age and pump condition: of those installed in the 1990s, 52% had intact base plates. This compares with 83% of those installed between 2000 and 2009 and 100% of those handpumps installed from 2010 onwards ( $p = 0.005$ ). Hydrochemical properties may also be influencing the condition of the pump stand. While pH of water supplied was similar for those handpumps with and without pump stand corrosion (average of 7.5 vs. 7.4, respectively), there was a significant association between electrical conductivity of groundwater and discernible damage to the base plate ( $p = 0.031$ ; 1,052  $\mu\text{S}/\text{cm}$  with pump stand corrosion vs. 750  $\mu\text{S}/\text{cm}$  without pump stand corrosion).

In the immediate term, there is an urgent need to repair and rehabilitate the handpumps with damaged base plates. Community-based committees are generally responsible for managing the maintenance of communal water points in Vanuatu. However, when it comes to the Nira AF-85, the absence of spare part supply chains renders it impossible for communities to coordinate repair activities when replacement parts are needed. In response to this constraint, 11 communities had encased their pump stand in concrete (Figure 7). This measure exhibited a significant protective effect, reducing the adjusted odds of *E. coli* by 97% (AOR 0.026, 95% CI 0.0026–0.25,  $p = 0.002$ ). Encouraging and supporting other communities to replicate this strategy could yield substantial water quality improvements and health benefits at a relatively low cost. However, such stopgap measures do not obviate the need to confront the longer-term challenge of managing and maintaining rural water supply infrastructure across Vanuatu's many islands and strengthening the enabling environment upon which sustainable water services depend.
