The effects of conversion of tropical rainforest to rubber plantation on splash erosion in Xishuangbanna, SW China

Wenjie Liu, Qinpu Luo, Jintao Li, Pingyuan Wang, Hongjian Lu, Wenyao Liu and Hongmei Li

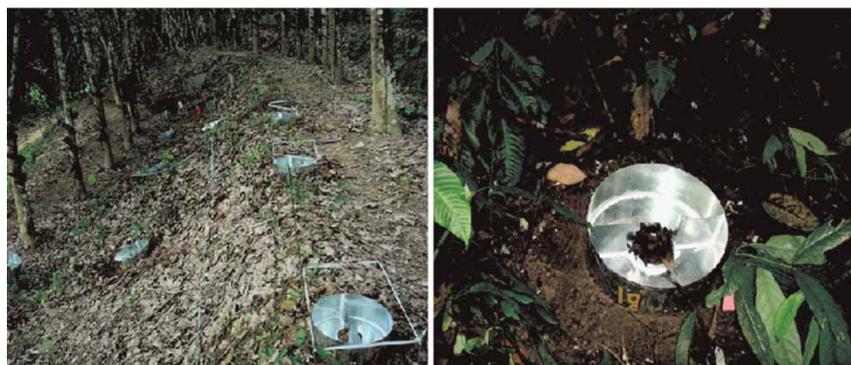
Figure 1 | Morgan-type splash cups installed on the floor to collect soil sediment splashed from the ground surface in the bench-terraced rubber plantation (left) and the tropical rainforest (right).

Actual splash erosion rate is defined as the amount of the undisturbed soil per unit source area that was mobilized by rainsplash. It was evaluated by use of Morgan-type splash cups (Nanko *et al.* 2008; Mizugaki *et al.* 2010). Three splash cups were randomly installed in the tropical rainforest and nine in the rubber plantation (three in terrace bench and six in riser bank). The minimum distance between the splash cups within each site was 1.5 m (Figure 1). The splashed soil materials were dried at 105 °C for 24 h and then weighed. The actual splash erosion rate for a given observation period was calculated by averaging the actual splash erosion rate from all splash cups installed. Observations were conducted during six periods (see Table 1) between 10 August and 15 November 2010. The splash cups were re-installed after each observation period.
