Long-term hydrological changes after various river regulation measures: are we responsible for flow extremes?

Tímea Kiss, Károly Fiala, György Sipos and Gábor Szatmári

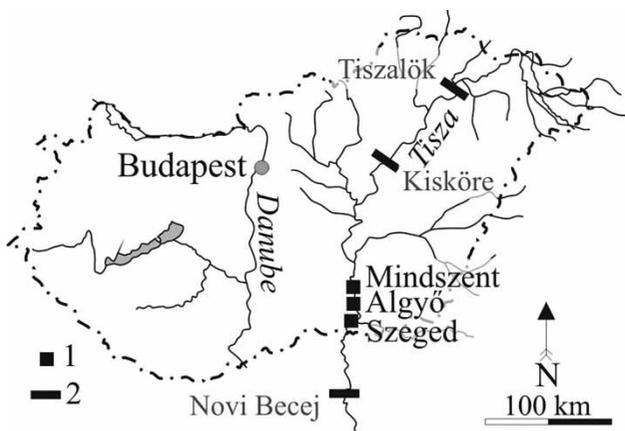
Figure 1 | The analysis was carried out on the Lower Tisza (Hungary) using the data from Mindszent, Algyő and Szeged gauging stations: 1: gauging station; 2: dam.

For the analyses performed in this study, long-term flow data were compiled for three hydrologic monitoring stations on the Lower Tisza (Figure 1) at Mindszent (217.8 rkm), Algyő (192 rkm) and Szeged (173.6 rkm). The Mindszent station is located between two large tributaries (Körös and

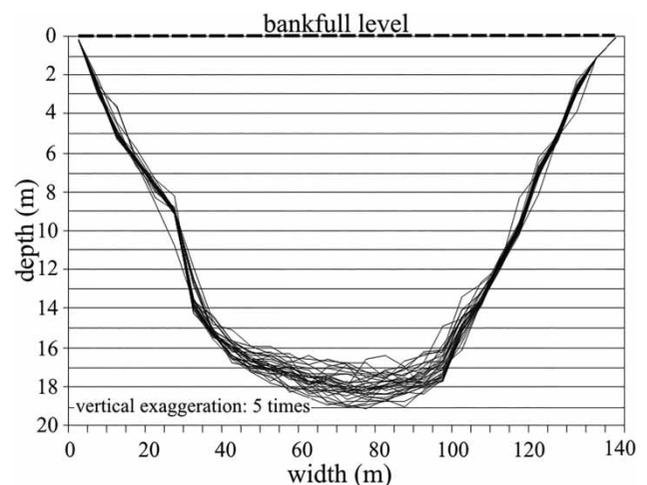
Figure 2 | River-bed changes in the Tisza River at Algyő gauging station during the record flood in 2000 based on daily channel surveys (Data source: ATIVIZIG).

(by 3–5 m), while during falling stages or flood peaks (especially during impoundment), in-channel aggradation occurs (Figure 2).

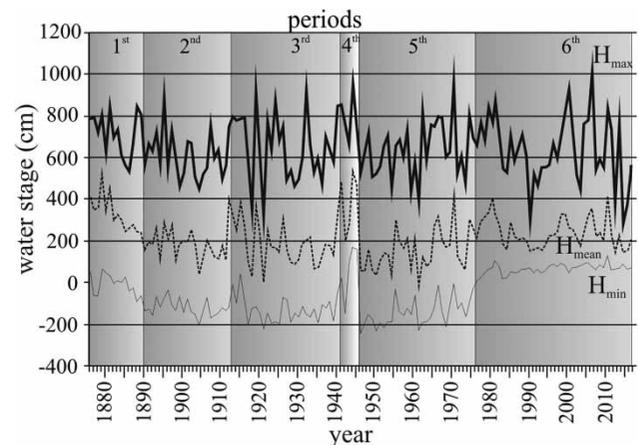
Figure 3 | Highest (H_{max}), mean (H_{mean}) and lowest (H_{min}) annual stages at Szeged measured between 1876 and 2017.

temporal changes in these parameters. Based on the hierarchical divisive multiple change point analysis of the stage data, the years between 1876 and 2017 are divided into six periods (Figures 3–6).

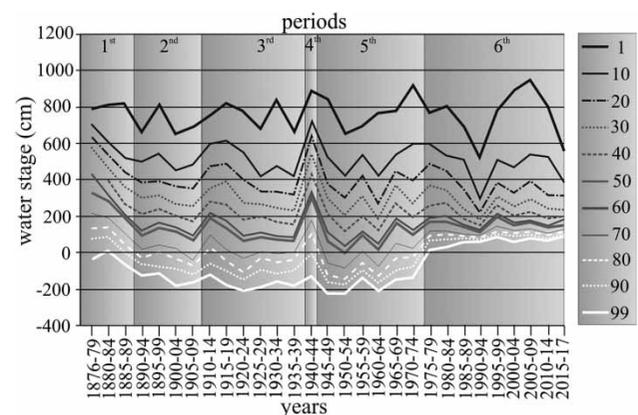
Figure 4 | Water stage values corresponding to certain exceedance probabilities at Szeged gauging station (1876–2017).

Stage exceedance probabilities were set up on a half-decade scale to describe stage frequencies. First, the stage values were sorted in decreasing numerical order. The total length of five years was considered as 100%, and the stage data were sampled at given (1%, 10%, 20%, etc.) frequencies.

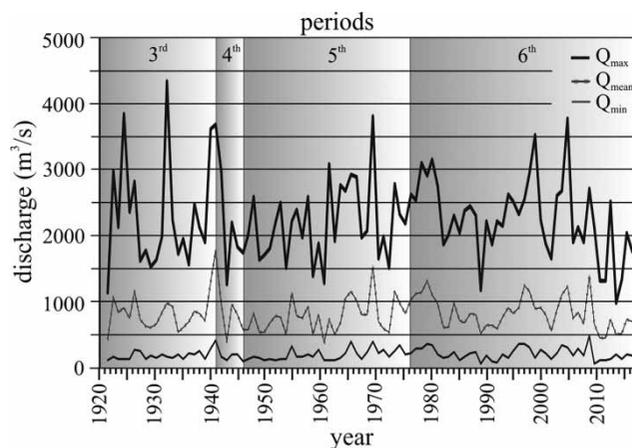
Figure 5 | Highest (Q_{max}), mean (Q_{mean}) and lowest (Q_{min}) annual discharge values at Szeged between 1921 and 2017.

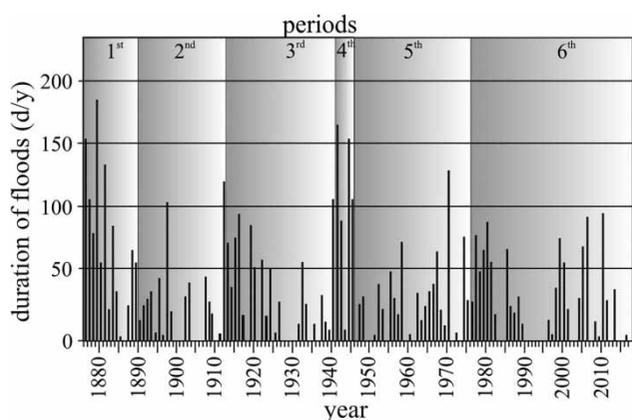
Figure 6 | Annual duration of floods (d/y) at Szeged (bankfull level: 520 cm).

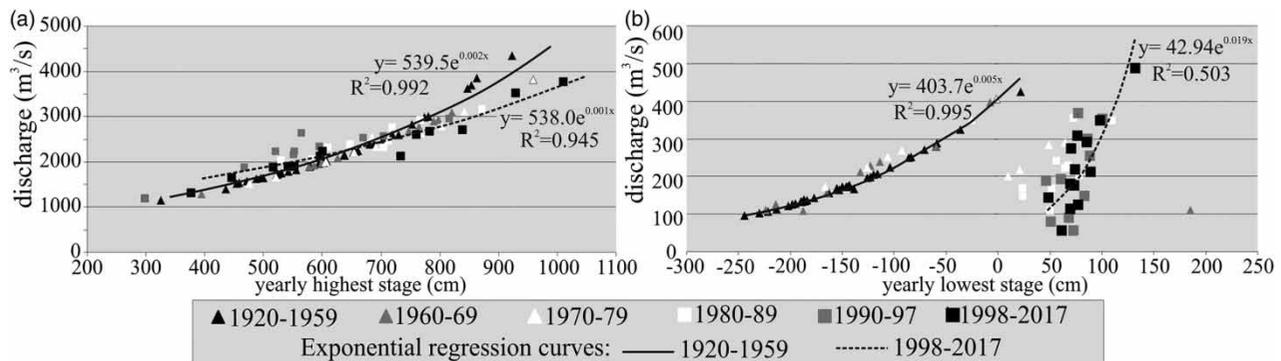
Figure 7 | Stage–discharge relationships of the highest yearly stages (a) and of the lowest yearly stages (b) measured at Szeged. The exponential regression curves of the first and last periods are also indicated.

however, after 1959, it became weak for low stages (R^2 : 0.332–0.503; Figure 7).

From the statistical point of view, the sixth period (1977–2017) was more uniform, as the probability curves shifted upward, close to each other. Floods lasted 8% of the period (mean D_f : 30 d/y), exactly as in the fifth period. Within the sixth period, the years between 1998 and 2011 must be highlighted, although the existence of this interval was not indicated by the hierarchical divisive multiple change point analysis. During these years, the flood duration increased to 11%. The longest flood (102 d) occurred in 2010, but the new record level (H_{RF} : 1,009 cm) was set in 2006; thus, the peak flood height increased by 55 cm. The two floods were quite different in character: the 2006 flood was due to the backwater effect of the Danube, while the 2010 flood was an independent flood, arriving from the upstream section (Vágás & Bezdán 2015). The correlation between the discharge and stage values of the highest yearly waters was declining in the 1980s (R^2 : 0.906) and 1990s (R^2 : 0.835), but during the 2000s, it became stronger again (R^2 : 0.945). Another very characteristic feature of the period is the rise in low stages. The level of the mean annual minimum stages increased by 205 cm, and the $EP_{90-70\%}$ curves shifted considerably upward; thus, during the whole period, water levels were above ‘0 cm’ (D_l : 0 d/y), and the duration of low discharges decreased (D_l : 18 d/y). At the same time, the mean discharge of the lowest stages increased to 220 m³/s, and their $Q-H$ values were substantially less correlated than during previous hydrologic periods (Figure 7).

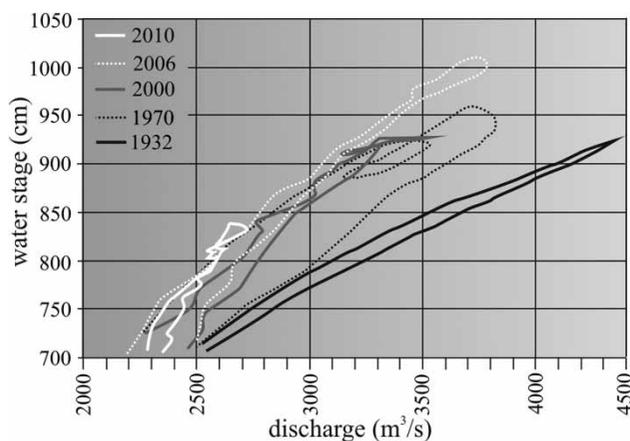
Figure 8 | Stage–discharge curves of some great floods at Szeged gauging station.

The Tisza is characterised by looped stage–discharge curves, like other low-gradient sand-bedded rivers with changing hydraulic channels or unsteady flow (Chow 1959). Thus, the discharge for a certain stage is much higher during the rising stage than during the falling stage of a flood (Figure 8); therefore, the Q - H values create a loop in an anti-clockwise direction. The speciality of these curves is their high hysteresis and upward shift. For example, in the 1970 flood during the rising stage, a discharge of $3,500 \text{ m}^3/\text{s}$ produced a water stage of only 885 cm at Szeged; however, during the falling stage, a similar discharge value corresponded to a much higher stage (930 cm). The changing flood conveyance of the river during the 20th to 21st centuries is well reflected by the upward shift of these loops (i.e., the same discharge is associated with higher stage values). Therefore, the maximum stage (952 cm) measured in 1970 was exceeded at Szeged in 2006 (1,009 cm) without any increase in discharge (1970: $3,820 \text{ m}^3/\text{s}$; 2006: $3,780 \text{ m}^3/\text{s}$).

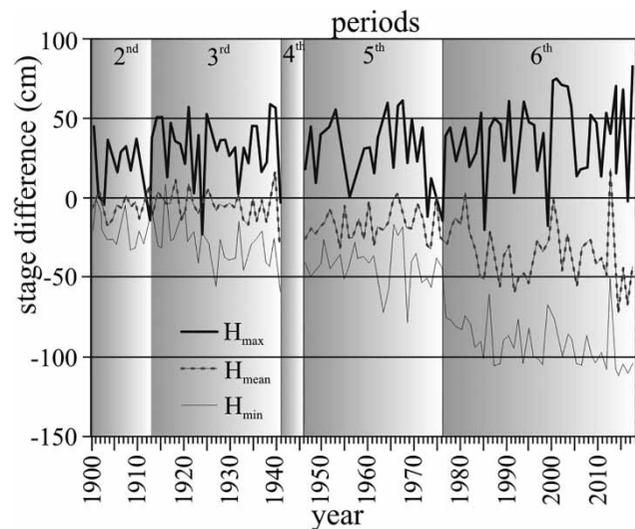
Figure 9 | Differences (cm) in the maximum, mean and minimum annual stage levels at Mindszent and Szeged gauging stations. Positive numbers refer to higher values upstream (Mindszent), and negative values refer to higher values downstream (Szeged).

The comparison of the datasets indicates that at the two gauging stations, the hydrological data have different trends, which is the most obvious for the sixth period (1977–2017). Usually, the flood levels were higher (max. by 75 cm) at Mindszent than at Szeged. However, in some years, the floods were 11–25 cm higher at Szeged, due to simultaneous flooding of the Maros or pronounced impoundment by the Danube (Vágás & Bezdán 2015). Since 1901, new record flood levels were detected at Szeged four times (1919, 1932, 1971 and 2006), whereas the level of flood peaks increased by 93 cm. However, at Mindszent, a fifth record flood appeared in 2000, raising the level of peak floods by 111 cm. Simultaneously with the increasing flood levels at Mindszent, their duration also increased, as at the beginning (1900–1912), floods were longer at Mindszent than at Szeged by only 4 d/y on average, but in the last period (1977–2017), they were already longer by 8 d/y, and during the 1998–2011 flood years, their duration increased even more (D_f : 11 d/y).

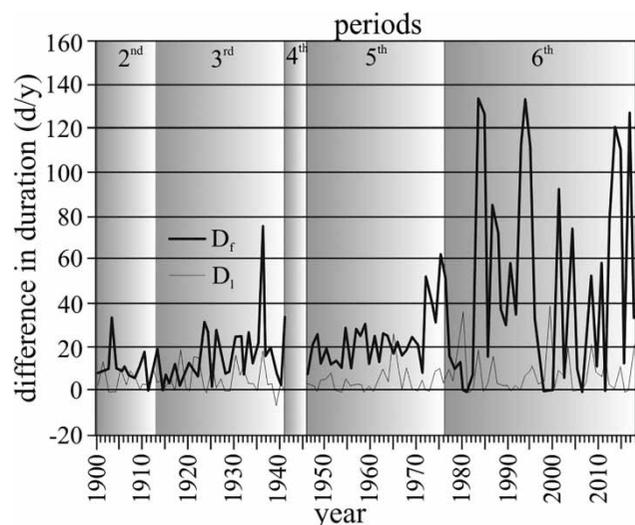
Figure 10 | Differences in flood (D_f) and low stage (D_l) durations (d/y) at Mindszent and Szeged gauging stations. Higher numbers refer to longer floods or lower stages upstream (at Mindszent).

Not only floods but also low stages are different upstream at Mindszent. The level of low stages decreased more remarkably and in an accelerated way: in 1900–1912, their level was only 22 cm lower at Mindszent than at Szeged, but since 1977, the difference has increased to 92 cm. Similarly, the total decrease in the recorded minimum stages was much higher at Mindszent (96 cm) than at Szeged (76 cm). The duration of low stages (D_l : 133 d) was quite long in the upstream section, although at Szeged, they have not occurred since 1976.

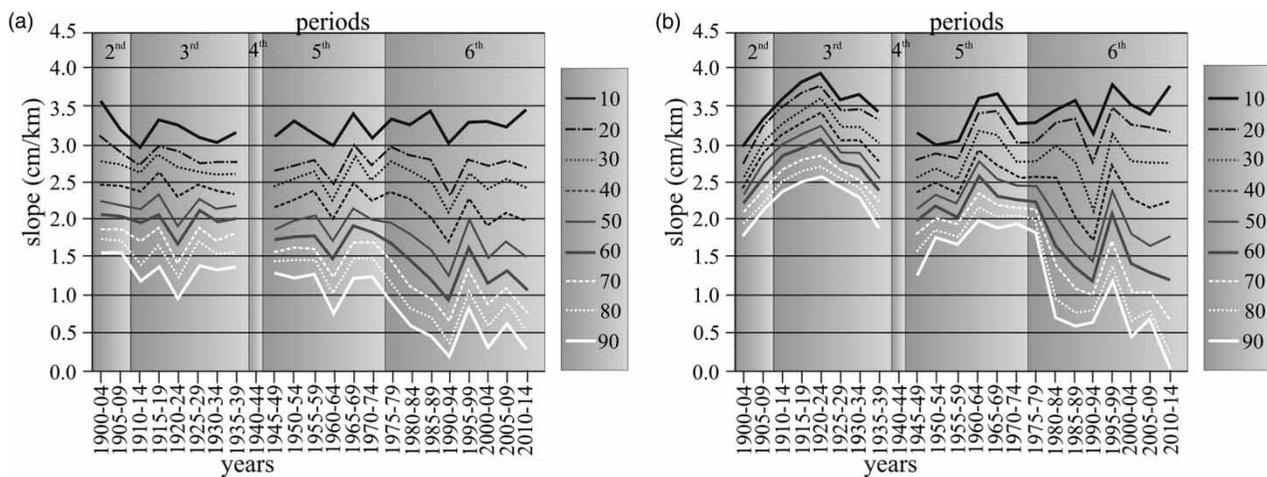
Figure 11 | Changes in water slope values of given (10–90%) frequency curves: (a) water slope conditions of the upstream section (Mindszent–Algyő); (b) water slope conditions of the downstream section (Algyő–Szeged).

Based on the stage values, the water surface slope was also calculated across the three gauging stations. The average water slope of the Lower Tisza between Mindszent and Algyő is only 2.0 cm/km, while between Algyő and Szeged, it increases to 2.4 cm/km. The steeper water slope (by 10–20%) of the downstream section is characteristic of all periods.

However, the temporal trends in water slope changes of the two sections were different. In the upstream section, the water slope frequency curves dropped in the first half of the 20th century (Figure 11), while in the downstream section, the curves shifted considerably upward (by 30–50%) until 1924, and they dropped since the late 1920s. The period of 1941–1945 could not be evaluated precisely because the war made impossible the measurement of water levels at Mindszent and Algyő. In the next period (1947–1976), the water slope values of the upstream section remained the same (and slightly dropped in the early 1960s), although in the downstream section they started to increase but did not reach the values of the early 20th century. Similar changes characterise the last period (1977–2017), as in both sections, the curves spread, and very low water slope values appeared. While slope values lower than 1 cm/km appeared in the upstream section as early as 1960–1964, they emerged in the downstream section only since the 1980s. In extreme cases, the water slope was 0 cm/km. During the last period, there was a sudden increase (by

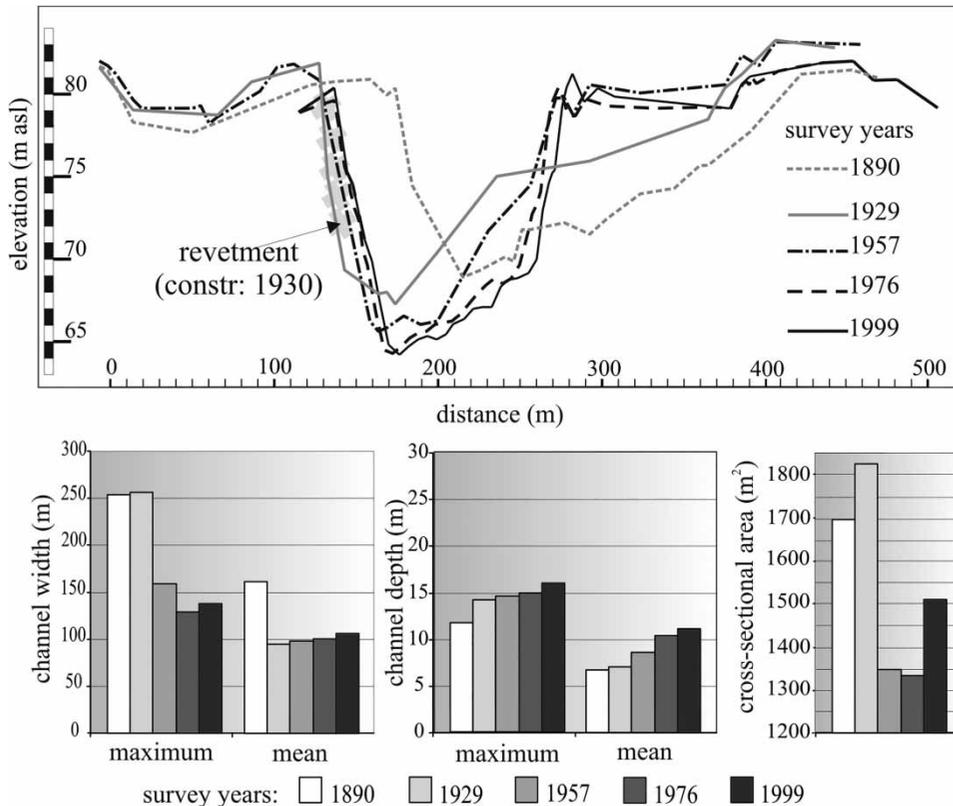
Figure 12 | Cross-sectional channel changes close to the Mindszent gauging station based on repeated channel surveys between 1890 and 1990 (Kiss *et al.* 2008).

(Figure 12), as the section became deeper (by 2.4 m, 20%) and slightly wider (by 10 m, 4%), and its area increased (by 124 m², 7%). Channel incision is also indicated by the decrease in the lowest water stages on record (by 138 cm at Szeged) and the falling level of exceedance probability curves. The higher flood conveyance of the channel explains the small range of stage fluctuations, the decrease in the highest annual stages, and the shorter floods. However, as floods could not spread over the former floodplain but remained in the confined active one, the peak flood levels increased by 88 cm; thus, the artificial levees had to be heightened (Lászlóffy 1982), although the reconnection of the former floodplain areas also could be a cost-effective long-term solution to reduce flood levels and flood risk (Guida *et al.* 2015). Similar flood level increases caused by artificial levee construction were detected on the Mississippi River (Smith & Winkley 1996; Remo *et al.* 2009, 2012).

The channel cross sections indicate that in response to the revetment construction, the flood conveyance decreased dramatically until 1976 (Figure 12). Despite the ongoing incision (by 3.2 m), the channel cross-sectional area decreased considerably (by 11%) because on the side opposite the revetments, ongoing point bar accumulation reduced the channel width (by 12–48%; Kiss *et al.* 2008). Therefore, the channel parameters decreased: while in 1929, the channel was 263 m wide and 15 m deep

(cross-sectional area of 1,825 m²), it became only 129 m wide and 14.8 m deep, and its cross-sectional area decreased to 1,342 m² by the 1976 survey (Kiss *et al.* 2008). The deterioration of the channel is reflected in the changes in water-surface slope, which slightly decreased since the mid-1920s.
