Long-term hydrological changes after various river regulation measures: are we responsible for flow extremes?

Tímea Kiss, Károly Fiala, György Sipos and Gábor Szatmári

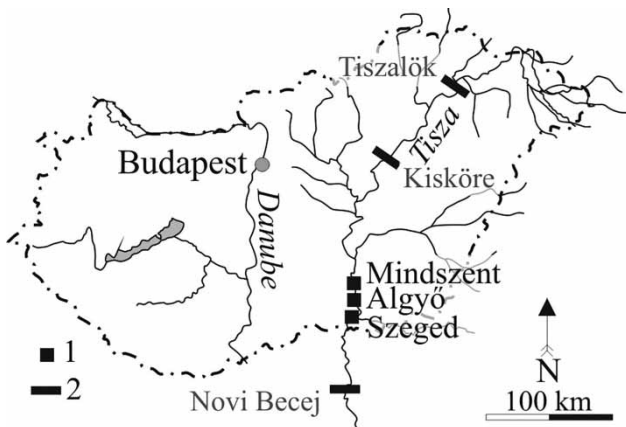
Figure 1 | The analysis was carried out on the Lower Tisza (Hungary) using the data from Mindszent, Algyő and Szeged gauging stations: 1: gauging station; 2: dam.

For the analyses performed in this study, long-term flow data were compiled for three hydrologic monitoring stations on the Lower Tisza (Figure 1) at Mindszent (217.8 rkm), Algyő (192 rkm) and Szeged (173.6 rkm). The Mindszent station is located between two large tributaries (Körös and

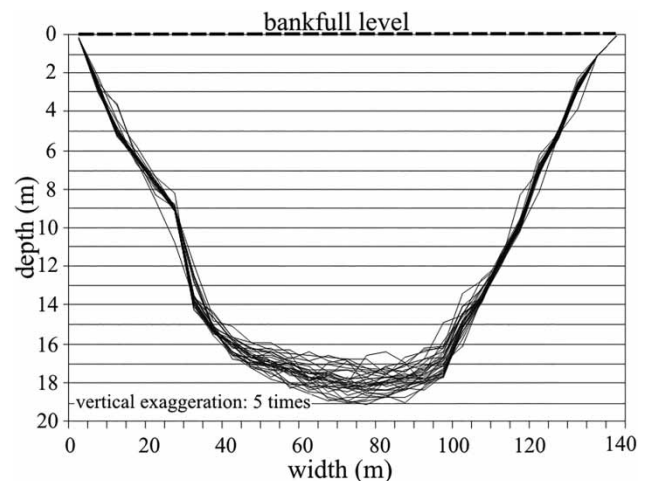
Figure 2 | River-bed changes in the Tisza River at Algyő gauging station during the record flood in 2000 based on daily channel surveys (Data source: ATIVIZIG).

(by 3–5 m), while during falling stages or flood peaks (especially during impoundment), in-channel aggradation occurs (Figure 2).

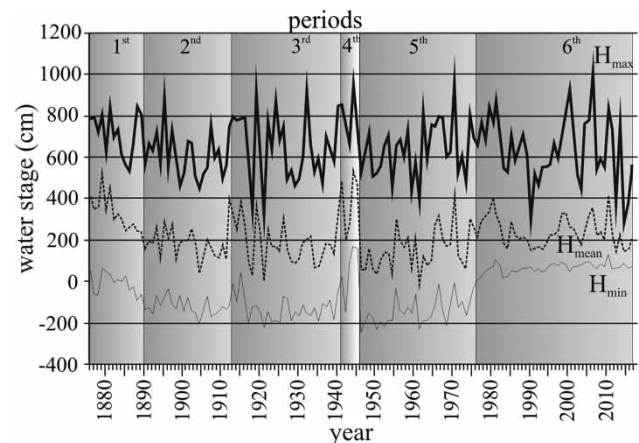
Figure 3 | Highest (H_{max}), mean (H_{mean}) and lowest (H_{min}) annual stages at Szeged measured between 1876 and 2017.

temporal changes in these parameters. Based on the hierarchical divisive multiple change point analysis of the stage data, the years between 1876 and 2017 are divided into six periods (Figures 3–6).

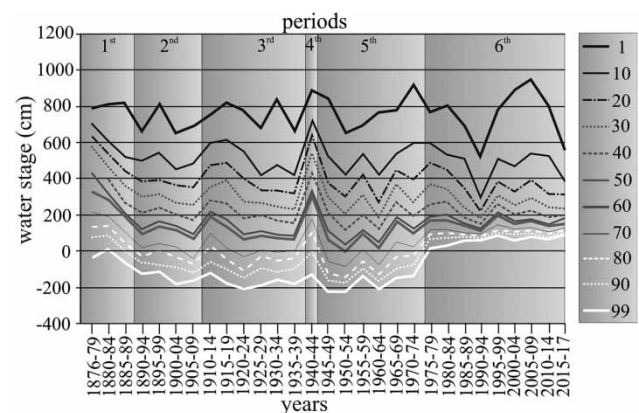
Figure 4 | Water stage values corresponding to certain exceedance probabilities at Szeged gauging station (1876–2017).

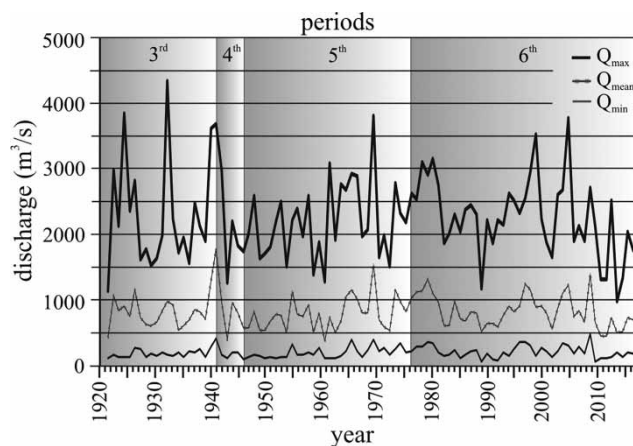
Figure 5 | Highest (Q_{max}), mean (Q_{mean}) and lowest (Q_{min}) annual discharge values at Szeged between 1921 and 2017.

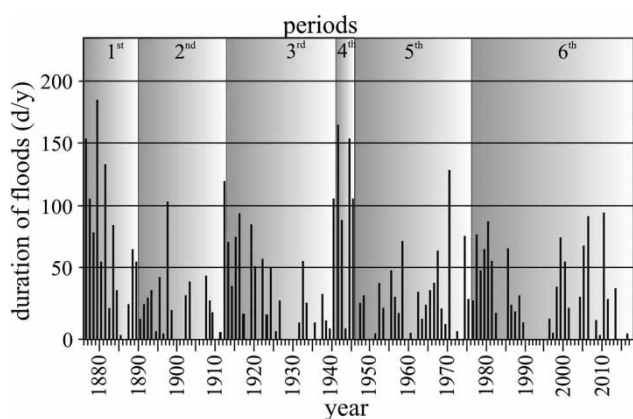
Figure 6 | Annual duration of floods (d/y) at Szeged (bankfull level: 520 cm).

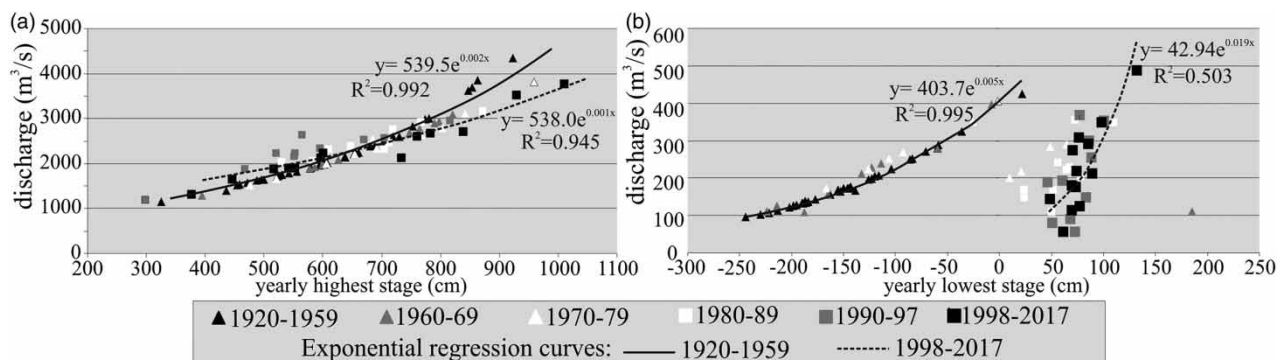
Figure 7 | Stage–discharge relationships of the highest yearly stages (a) and of the lowest yearly stages (b) measured at Szeged. The exponential regression curves of the first and last periods are also indicated.

however, after 1959, it became weak for low stages (R^2 : 0.332–0.503; Figure 7).

From the statistical point of view, the sixth period (1977–2017) was more uniform, as the probability curves shifted upward, close to each other. Floods lasted 8% of the period (mean D_f : 30 d/y), exactly as in the fifth period. Within the sixth period, the years between 1998 and 2011 must be highlighted, although the existence of this interval was not indicated by the hierarchical divisive multiple change point analysis. During these years, the flood duration increased to 11%. The longest flood (102 d) occurred in 2010, but the new record level (H_{RF} : 1,009 cm) was set in 2006; thus, the peak flood height increased by 55 cm. The two floods were quite different in character: the 2006 flood was due to the backwater effect of the Danube, while the 2010 flood was an independent flood, arriving from the upstream section (Vágás & Bezdán 2015). The correlation between the discharge and stage values of the highest yearly waters was declining in the 1980s (R^2 : 0.906) and 1990s (R^2 : 0.835), but during the 2000s, it became stronger again (R^2 : 0.945). Another very characteristic feature of the period is the rise in low stages. The level of the mean annual minimum stages increased by 205 cm, and the $EP_{90-70\%}$ curves shifted considerably upward; thus, during the whole period, water levels were above ‘0 cm’ (D_l : 0 d/y), and the duration of low discharges decreased (D_l : 18 d/y). At the same time, the mean discharge of the lowest stages increased to 220 m³/s, and their $Q-H$ values were substantially less correlated than during previous hydrologic periods (Figure 7).

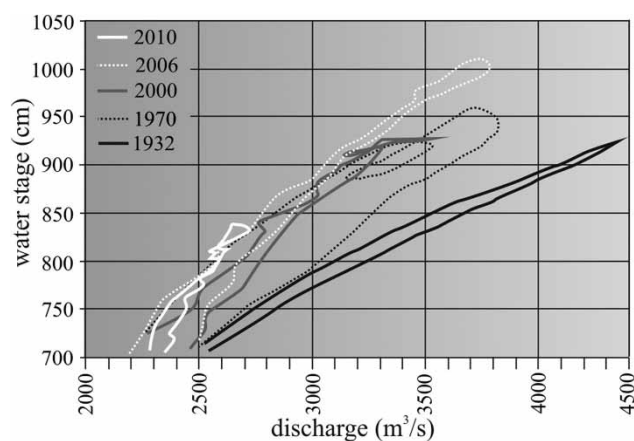
Figure 8 | Stage–discharge curves of some great floods at Szeged gauging station.

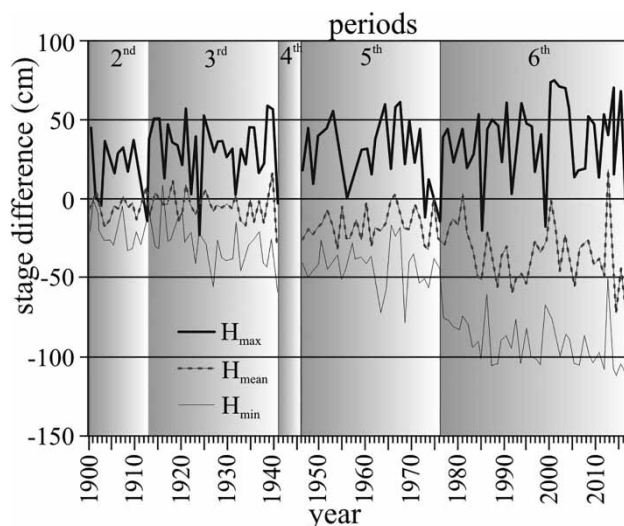
Figure 9 | Differences (cm) in the maximum, mean and minimum annual stage levels at Mindszent and Szeged gauging stations. Positive numbers refer to higher values upstream (Mindszent), and negative values refer to higher values downstream (Szeged).

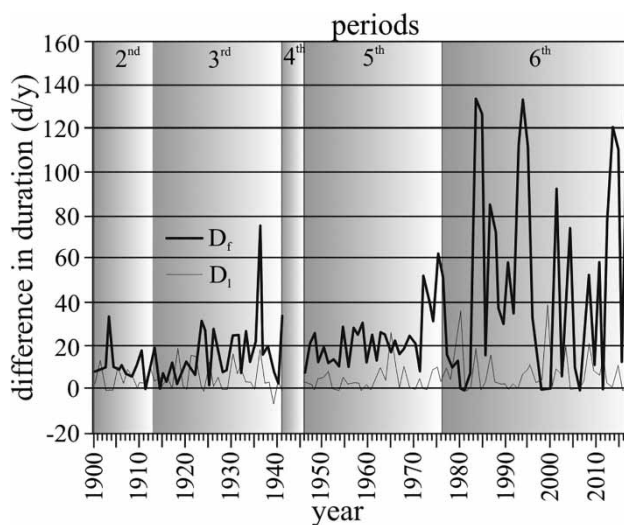
Figure 10 | Differences in flood (D_f) and low stage (D_l) durations (d/y) at Mindszent and Szeged gauging stations. Higher numbers refer to longer floods or lower stages upstream (at Mindszent).

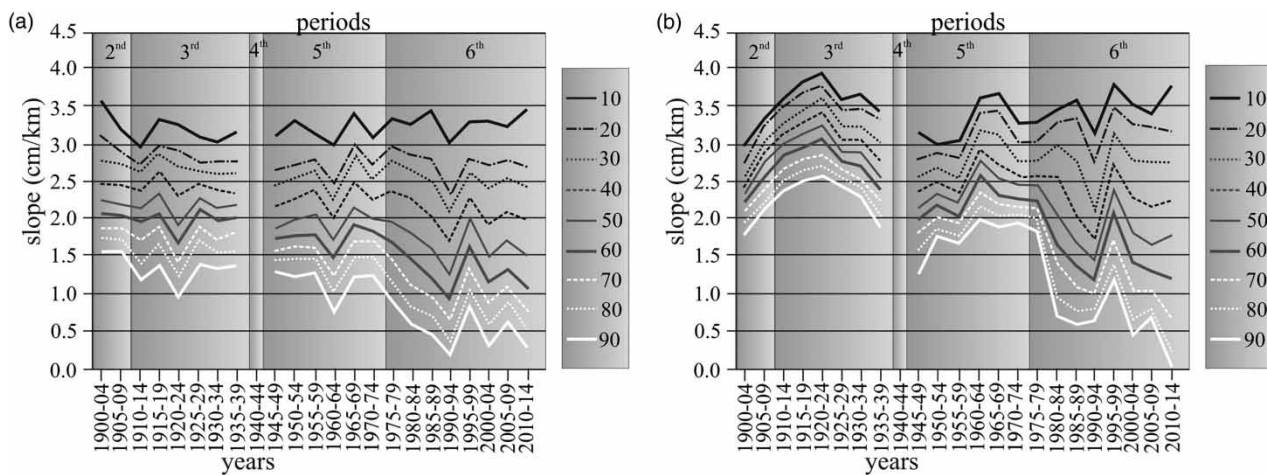
Figure 11 | Changes in water slope values of given (10–90%) frequency curves: (a) water slope conditions of the upstream section (Mindszent–Algyő); (b) water slope conditions of the downstream section (Algyő–Szeged).

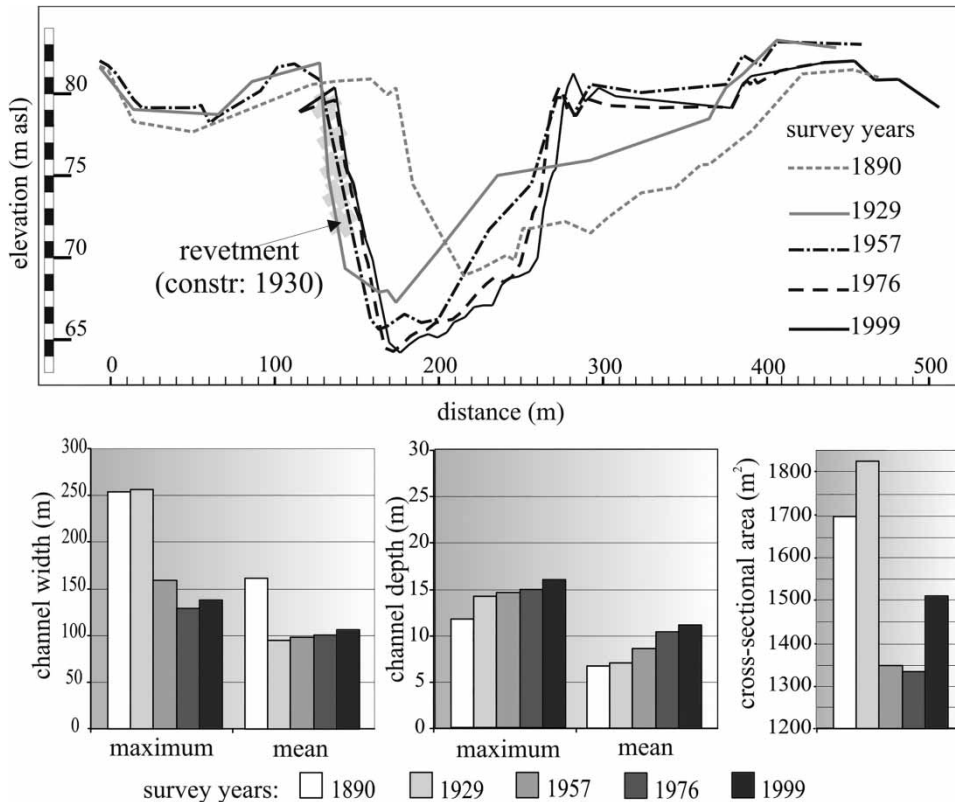
Figure 12 | Cross-sectional channel changes close to the Mindszent gauging station based on repeated channel surveys between 1890 and 1990 (Kiss *et al.* 2008).

(Figure 12), as the section became deeper (by 2.4 m, 20%) and slightly wider (by 10 m, 4%), and its area increased (by 124 m², 7%). Channel incision is also indicated by the decrease in the lowest water stages on record (by 138 cm at Szeged) and the falling level of exceedance probability curves. The higher flood conveyance of the channel explains the small range of stage fluctuations, the decrease in the highest annual stages, and the shorter floods. However, as floods could not spread over the former floodplain but remained in the confined active one, the peak flood levels increased by 88 cm; thus, the artificial levees had to be heightened (Lászlóffy 1982), although the reconnection of the former floodplain areas also could be a cost-effective long-term solution to reduce flood levels and flood risk (Guida *et al.* 2015). Similar flood level increases caused by artificial levee construction were detected on the Mississippi River (Smith & Winkley 1996; Remo *et al.* 2009, 2012).

The channel cross sections indicate that in response to the revetment construction, the flood conveyance decreased dramatically until 1976 (Figure 12). Despite the ongoing incision (by 3.2 m), the channel cross-sectional area decreased considerably (by 11%) because on the side opposite the revetments, ongoing point bar accumulation reduced the channel width (by 12–48%; Kiss *et al.* 2008). Therefore, the channel parameters decreased: while in 1929, the channel was 263 m wide and 15 m deep

(cross-sectional area of 1,825 m²), it became only 129 m wide and 14.8 m deep, and its cross-sectional area decreased to 1,342 m² by the 1976 survey (Kiss *et al.* 2008). The deterioration of the channel is reflected in the changes in water-surface slope, which slightly decreased since the mid-1920s.
