# The Evolution of Thermal Barrier Coatings in Gas Turbine Engine Applications

SUSAN MANNING MEIER and DINESH K. GUPTA

Pratt & Whitney  
East Hartford, Connecticut

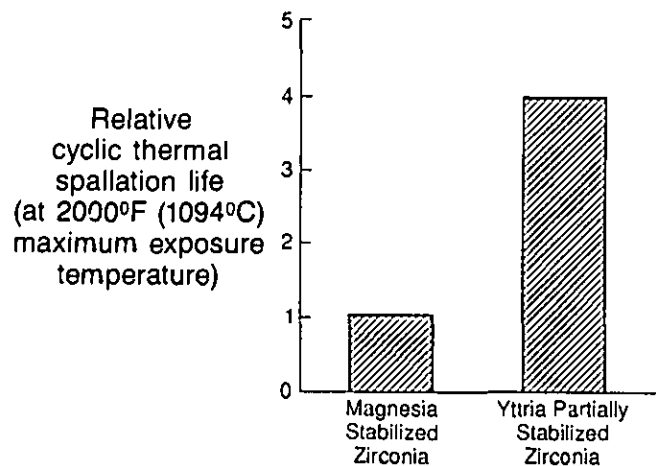
Fig. 8 Relative Cyclic Thermal Spallation Life at a Maximum Exposure Temperature of 1094°C.

As the temperatures in the combustor have been increased, the durability of this early combustor coating has become inadequate. The maximum use temperature of the plasma sprayed magnesia stabilized zirconia coating is on the order of 982°C since magnesia stabilized zirconia crystallographically destabilizes above 954°C (Figure 7). By replacing the 22 weight percent magnesia with the 7 weight percent yttria composition used successfully in the turbine section of the engine, the spallation life at temperatures above 982°C has been substantially improved (Stecura, 1979). Figure 8 shows that the thermal spallation life of a seven weight

percent yttria partially stabilized zirconia is approximately four times that of the 22 weight percent magnesia fully stabilized zirconia coating at 1094°C (Meier, et al., 1990, and Meier, et al., 1991a).
