Assessment of irrigation water allocation, Koftu, Ethiopia

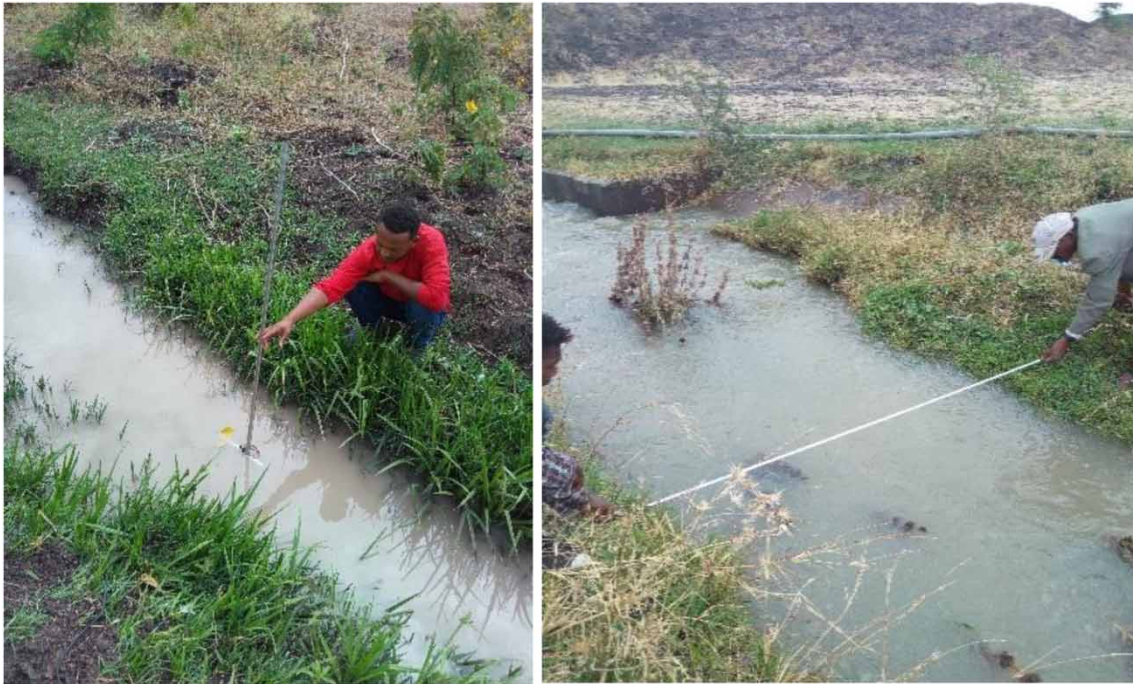
Figure 1 | Measuring canal depth, width, and flow of water.

The irrigation canal's true carrying capacity was determined using the current meter, with the replication of measurements taken once a week for 3 months at various locations along the canals to document temporal and geographical variations in irrigation water flows. The canal discharges were measured at 200-m intervals through secondary canals, starting at the system's intake, with 12 replications of measurements taken at each location. The discharge at the given location was computed using the area-velocity methodology and the mid-section method of discharge computation, with the replication of measurements to ensure accuracy. The diameters of canals were first measured with a tape meter, and then cross-sectional areas were calculated, with multiple replications of measurements taken to reduce measurement errors. In the research areas, the waterways are clay canals with irregular shapes, and multiple replications of measurements were taken to account for variations in shape and size. As a result, the velocity of flow through the canal was measured using a current meter. The flow velocity was calculated using the propeller rotation speed (n) obtained by the control unit at three segments of canal flow width. The mean flow velocity was calculated using the average number of rotation speeds (Figure 1).

Flow depth was measured through canals at specific locations, and flow rotations were recorded using a current meter and stopwatch. Following that, the actual discharge of each segment was calculated by multiplying the segment's average area by the velocity of flow. Lastly, the average real carrying capacity of the canal was calculated by aggregating the average discharge for each segment.

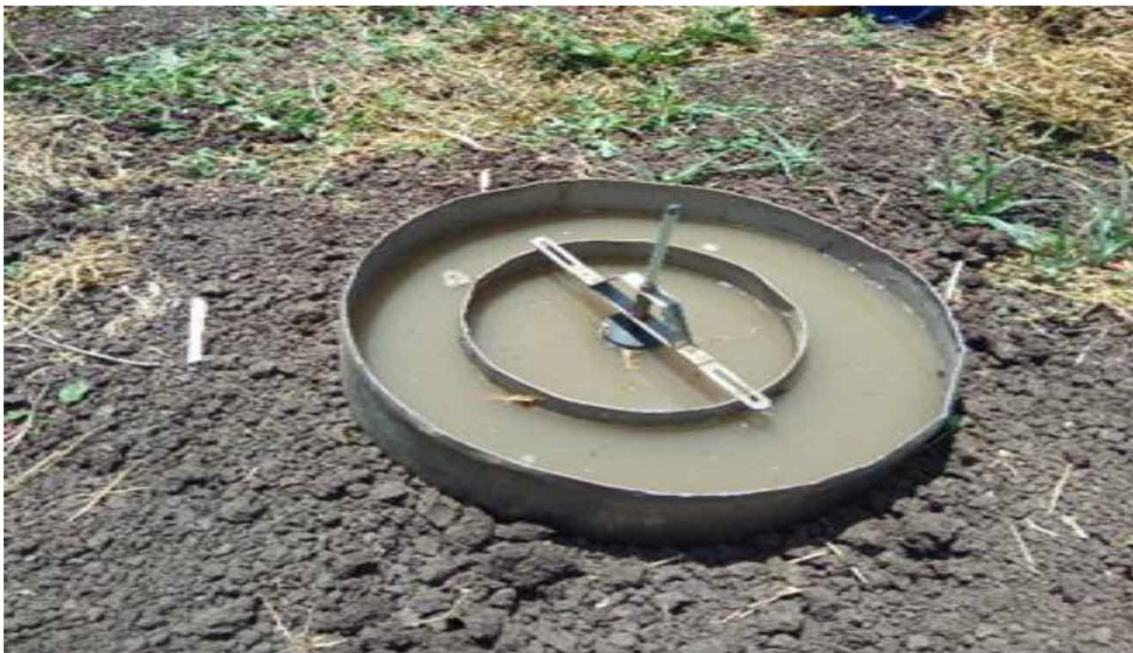
Figure 2 | Observation of the study area soil infiltration rate.

2.2.2.1. Infiltration rate of soil. The rate at which water drains into the soil is known as the infiltration rate. In millimeters, the depth of water that can permeate the soil in 1 h can be measured. Averaging the recorded experimental data yielded 6.8 mm/h as the average basic infiltration rate for the studied region. The findings of the soil laboratory revealed that clay is the predominant soil texture in both research locations. A clay soil texture, as illustrated in Table 1, has a basic infiltration rate of 1–7 mm/h. According to FAO (2002), it is

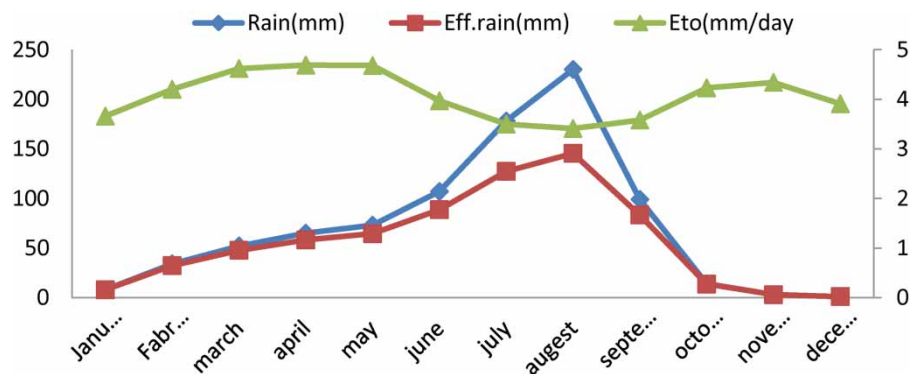
Figure 4 | Study area rainfall, effective rainfall, and Eto.

Rainfall data were created using meteorological data and CLIMWAT 2.0 from a neighboring Bishoftu station with the same Argo condition as the study area because the study location lacked a meteorological station. As a result, whereas the average total annual effective rainfall in the research region was found to be 651.2 mm, the average

annual total rainfall was found to be 837.5 mm. June through September are the wettest months of the year. Over the entire year, the reference evapotranspiration is constantly high (Figure 4). The region is regarded as a moisture-stressed area; thus, irrigation is required to maintain agricultural production.
