# Assessment of effectiveness of water safety plans (WSP) on water quality in rural communities of Anambra State, south-eastern Nigeria

## ABSTRACT

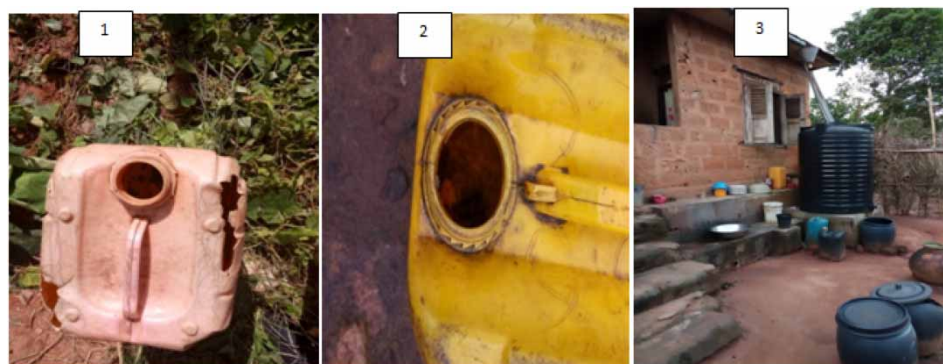
**Figure 2** | (1) Damaged and unhygienic transport container as seen at a source in Aguata; (2) Inside view of an empty transport container in Anambra-East; (3) Water storage at a household in Anambra-East.

Assessment of sanitary conditions of water transport and storage containers had 10 and 83% of respondents claiming to clean the containers daily and frequently respectively. However a random visual assessment showed the containers to have poor hygiene conditions (Figure 2).

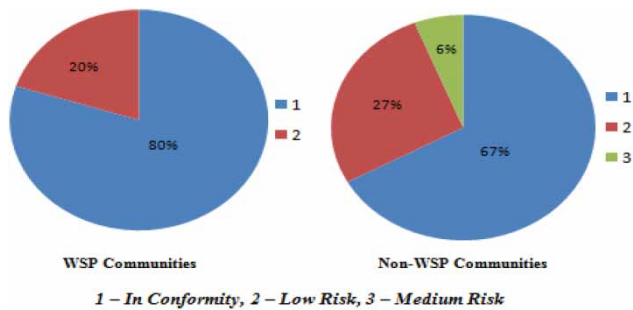
**Figure 3** | WHO assessment of source water from WSP and non-WSP implementing communities.

Assessment of WSP and non-WSP implementing communities shows that twelve (12) of the fifteen (15) communities in the WSP implementing communities across both local councils have their source waters devoid of contamination, and this represents 80%. The other 20% are of low risk values. For the non-WSP implementing communities, 10 of 15 representing approximately 67% are devoid of contamination, 4 (approximately 27%) are of low risk value while one (1) community had its source to be of medium risk value.

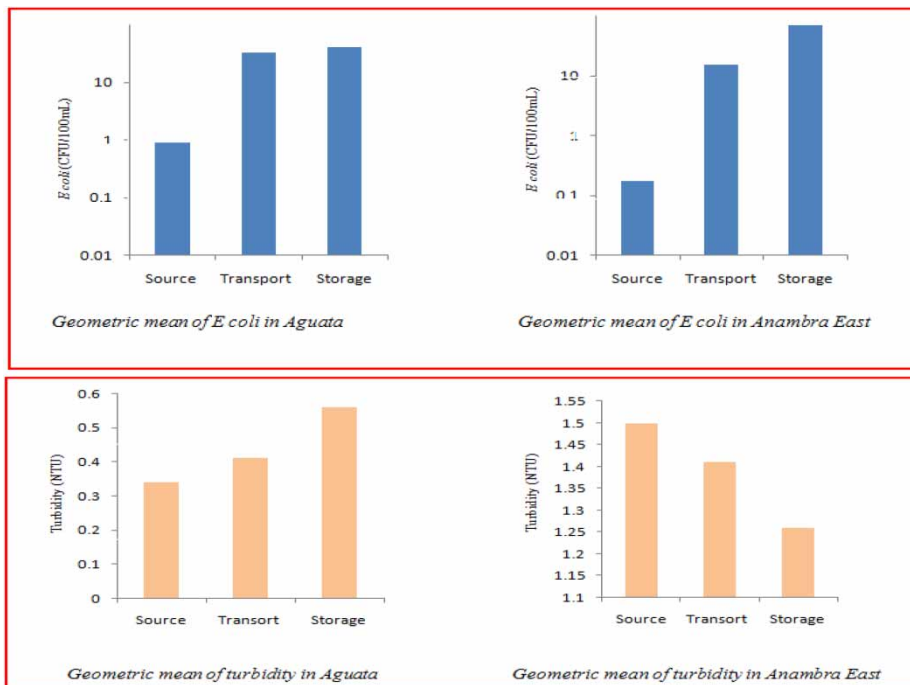
**Figure 4** | Geometric mean of *E. coli* and turbidity in source, transport and storage samples.

Geometric mean water quality parameters were calculated for all household water samples (*n* = 120) (Table 3). In source water, geometric mean *E. coli* concentration was 0.54 CFU/100 mL and turbidity was 0.92 NTU. In transport and storage containers, geometric mean *E. coli* concentrations were 24.3 CFU/100 mL and 55.9 CFU/100 mL and turbidity was 0.91 NTU and 0.91 NTU, respectively. General observation indicates geometric mean of *E. coli* concentration and turbidity increased from source through storage, indicating water quality deterioration along the water chain (Figure 3). *E. coli* concentrations were statistically significantly higher in transported samples from Aguata than those of Anambra East, while for storage, concentrations were higher for Anambra East than in Aguata. Three (3) source samples in Aguata recorded *E. coli* contamination while seven (7) recorded same in Anambra East.

Statistical distribution trends of *E. coli* and turbidity in source, transport and storage samples for the two study areas are presented in Figure 4.

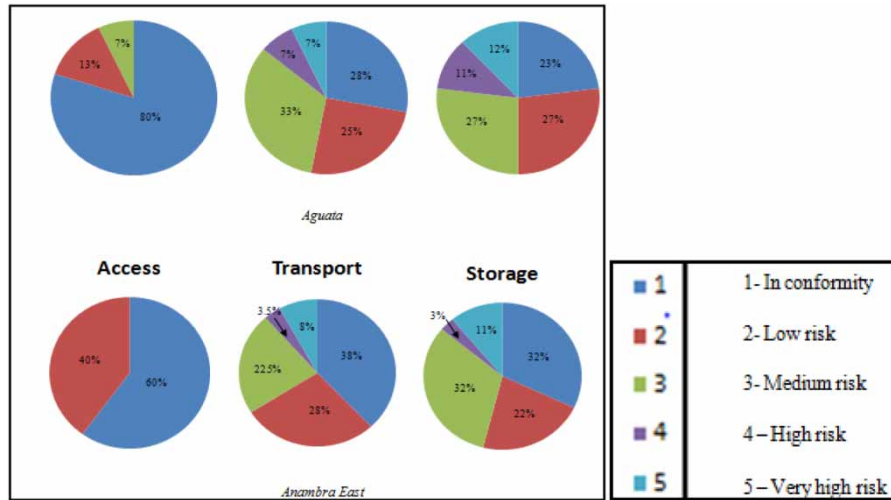
Figure 5 | Percentage of source, transport, and storage samples according to WHO risk category.

Assessment indicates (Figure 5) eighty percent (80%) of the source samples in Aguata to be within conformity of the standard, 13% with low risk and 7% with medium risk. In Anambra East, the source samples had 60% in conformity and the remaining 40% to be of low risk. For the transport and stored water samples, the trends of variation were similar, but Anambra East had a higher percentage of samples within conformity of potable water as defined by the WHO standard. General assessment indicates that transport and storage container samples from Anambra East communities were prone to more recontamination, as compared to Aguata communities.
