Assessment of effectiveness of water safety plans (WSP) on water quality in rural communities of Anambra State, south-eastern Nigeria

ABSTRACT

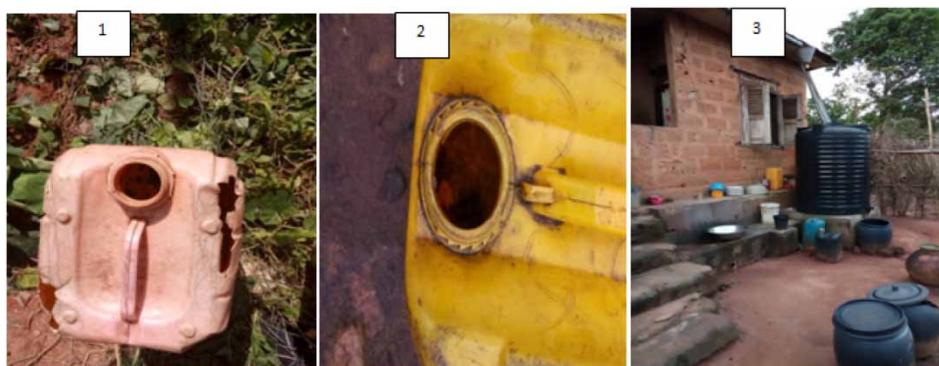
**Figure 2** | (1) Damaged and unhygienic transport container as seen at a source in Aguata; (2) Inside view of an empty transport container in Anambra-East; (3) Water storage at a household in Anambra-East.

Assessment of sanitary conditions of water transport and storage containers had 10 and 83% of respondents claiming to clean the containers daily and frequently respectively. However a random visual assessment showed the containers to have poor hygiene conditions (Figure 2).

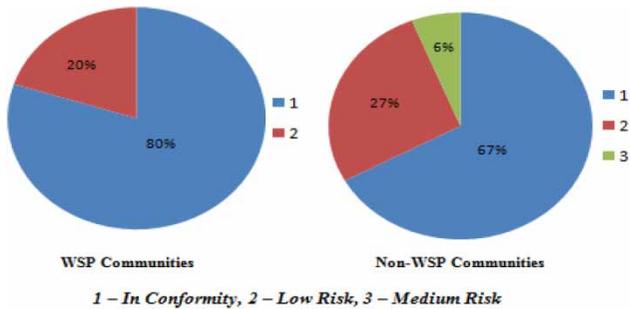
Figure 3 | WHO assessment of source water from WSP and non-WSP implementing communities.

Assessment of WSP and non-WSP implementing communities shows that twelve (12) of the fifteen (15) communities in the WSP implementing communities across both local councils have their source waters devoid of contamination, and this represents 80%. The other 20% are of low risk values. For the non-WSP implementing communities, 10 of 15 representing approximately 67% are devoid of contamination, 4 (approximately 27%) are of low risk value while one (1) community had its source to be of medium risk value.

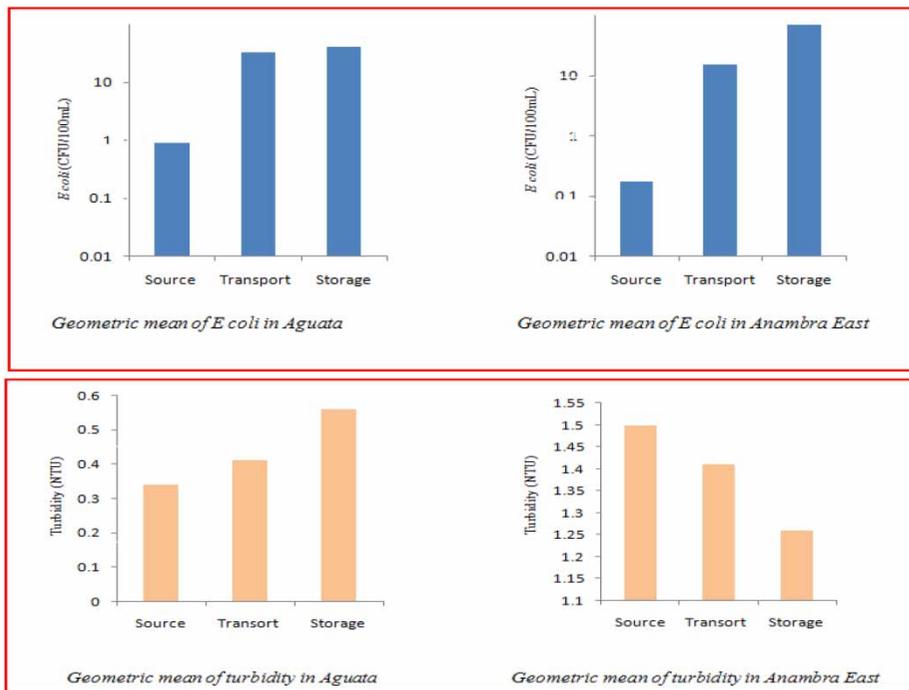
Figure 4 | Geometric mean of *E. coli* and turbidity in source, transport and storage samples.

Geometric mean water quality parameters were calculated for all household water samples (n = 120) (Table 3). In source water, geometric mean *E. coli* concentration was 0.54 CFU/100 mL and turbidity was 0.92 NTU. In transport and storage containers, geometric mean *E. coli* concentrations were 24.3 CFU/100 mL and 55.9 CFU/100 mL and turbidity was 0.91 NTU and 0.91 NTU, respectively. General observation indicates geometric mean of *E. coli* concentration and turbidity increased from source through storage, indicating water quality deterioration along the water chain (Figure 3). *E. coli* concentrations were statistically significantly higher in transported samples from Aguata than those of Anambra East, while for storage, concentrations were higher for Anambra East than in Aguata. Three (3) source samples in Aguata recorded *E. coli* contamination while seven (7) recorded same in Anambra East.

Statistical distribution trends of *E. coli* and turbidity in source, transport and storage samples for the two study areas are presented in Figure 4.

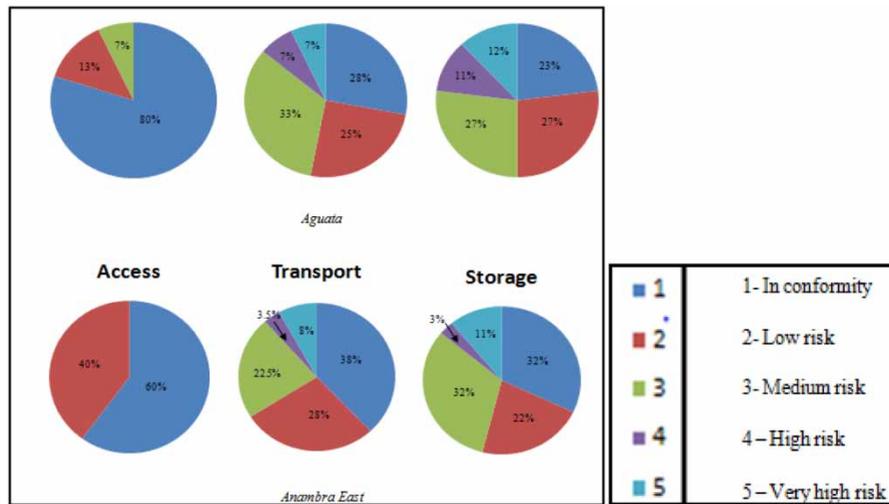
Figure 5 | Percentage of source, transport, and storage samples according to WHO risk category.

Assessment indicates (Figure 5) eighty percent (80%) of the source samples in Aguata to be within conformity of the standard, 13% with low risk and 7% with medium risk. In Anambra East, the source samples had 60% in conformity and the remaining 40% to be of low risk. For the transport and stored water samples, the trends of variation were similar, but Anambra East had a higher percentage of samples within conformity of potable water as defined by the WHO standard. General assessment indicates that transport and storage container samples from Anambra East communities were prone to more recontamination, as compared to Aguata communities.
