## Impacts of storage tanks under the indirect cold water supply system on household water quality: a case of Wakiso District, Uganda

**Key words:** indirect cold water supply system, tank cleaning, tank features, water quality

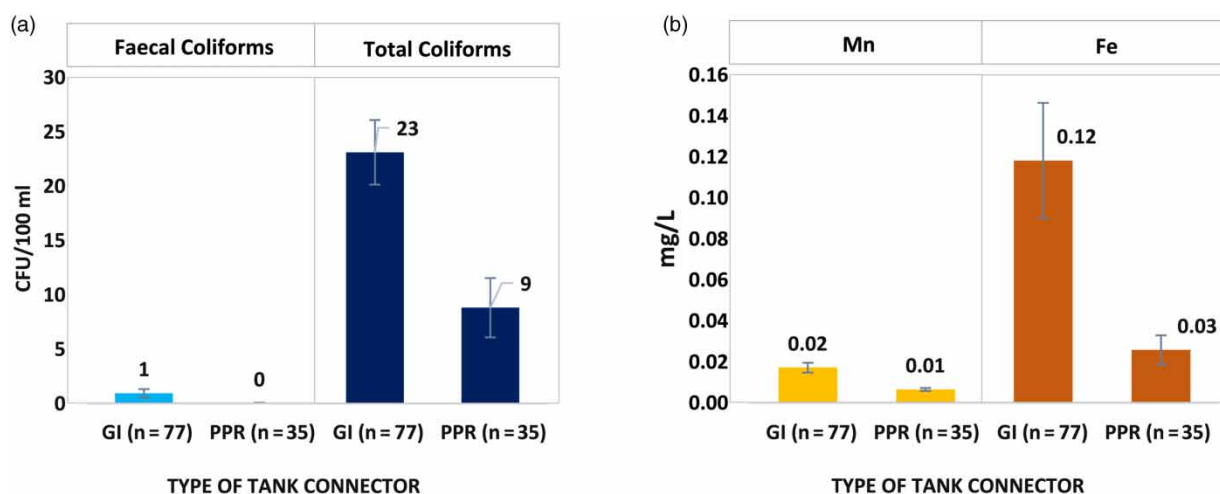
**Figure 3** | Quality of water flowing from storage tanks with different connectors (i.e., galvanised iron (GI) and polypropylene random copolymer (PPR) tank connectors); (a) faecal coliforms and total coliforms; (b) manganese (Mn) and Iron (Fe). Error bars represent the standard error around the mean values. Please refer to the online version of this paper to see this figure in colour: <http://dx.doi.org/10.2166/ws.2021.411>.

connectors. It was found that 31% of the tanks had PPR connectors while the remaining 69% had GI connectors. PPR connectors were common in new tank installation, while GI connectors were mainly used in old tank installations. The use of the connectors did not depend on the type of tank material, for instance, many plastic tanks were fitted with GI connectors, while some stainless steel tanks had PPR connectors. The analysis of microbiological indicators revealed significantly higher contamination of water stored or flowing from tanks with GI fittings compared with those with PPR fittings. As shown in [Figure 3](#), faecal coliforms were significantly higher ( $p = 0.035$ ) in water flowing from tanks with GI connectors (mean value 1 CFU/100 ml) compared with that flowing from tanks with PPR connectors that on average did not contain any faecal coliforms.

Similarly, total coliforms and HPC averaged 9 CFU/100 ml and 360 CFU/100 ml, respectively, in water from tanks with PPR connectors but were significantly higher ( $p = 0.008$  and  $0.002$  respectively) in that from tanks with GI connectors (mean value = 23 and 962 CFU/100 ml respectively). Mn and Fe levels were also significantly higher in water from tanks with GI connectors ( $p = 0.001$ ).

The effect of GI connectors on water quality was similar to the effect of GS tanks on water quality because of corrosion, a phenomenon that has been reported ([Lemon 2020](#)) to favour bacteria growth. The corrosion of GI connectors clearly stood out in stainless steel tanks that had them; with the tank surfaces appearing smooth and clean, while the area around the inlets, outlets, and washouts appeared clogged with corrosion deposits. This was even worse in old plastic tanks (i.e.,  $\geq 10$  years old). The surfaces of some of them (originally white in colour) had turned brownish (see [Figure 4](#)). It was observed that tanks that had PPR connectors generally had much cleaner water compared with those with GI connectors.
